PERMAFROST
TECHNOLOGY
FOUNDATION

FINAL REPORT

FOUNDATION STABILITY
RESEARCH

1417 JONES ROAD
FAIRBANKS, ALASKA

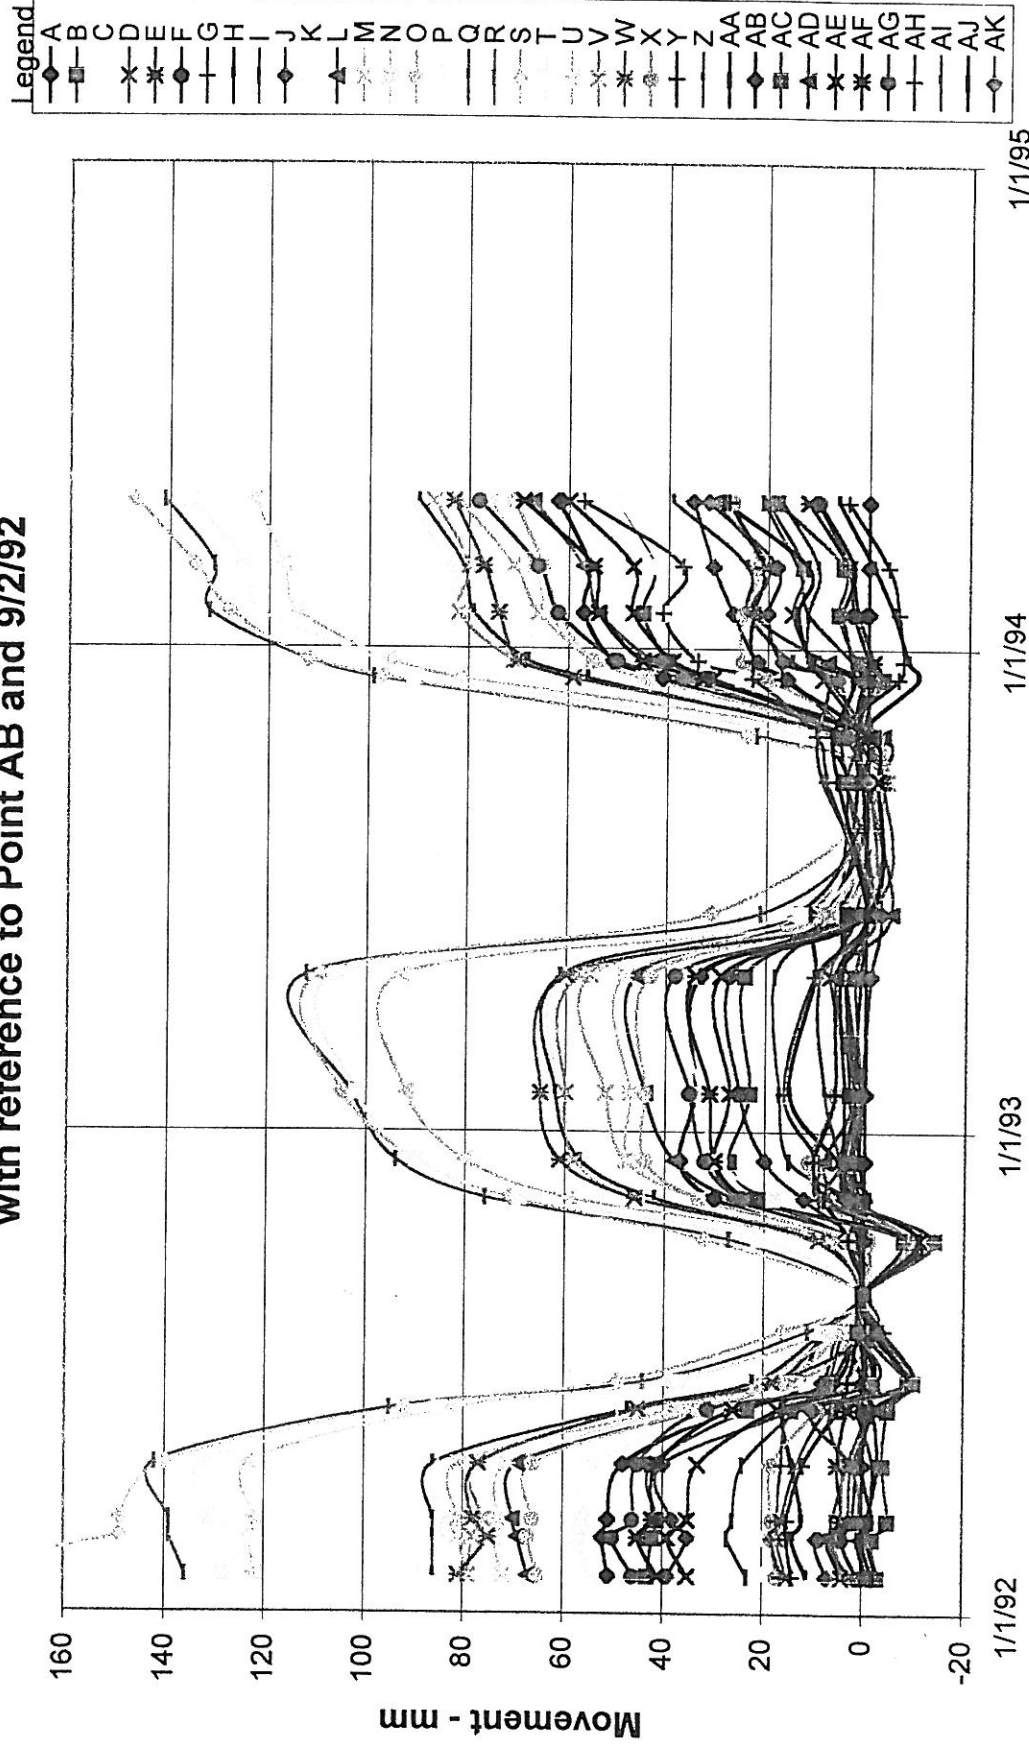
FIGURE 2

There were about two and one half years of data between the time the house was initially releveled by PTF and the time the Triodetic foundation was installed. Figure 2 shows all the data from this period on one graph using Point AB and September 2, 1992, as reference points. Point AB was chosen because, when that is done, most of the other data all show relative heave in the winter. Had another point been chosen, the conclusions would have been the same, but it would be harder to see the relationships. September 2, 1992, was chosen because that is first time when the seasonal frost is gone, and the relative elevations between various points should be a minimum. This does not mean that the house was level on that day. We are using that day to determine relative movement at other times of the year.

From this figure, it is obvious that there is a very significant seasonal differential movement, but not much long-term differential movement. How one chooses to present the data changes the graphical picture of the performance, but it does not affect the overall conclusions presented here. There was about 120 to 150 mm of differential movement caused by the freeze thaw cycles.

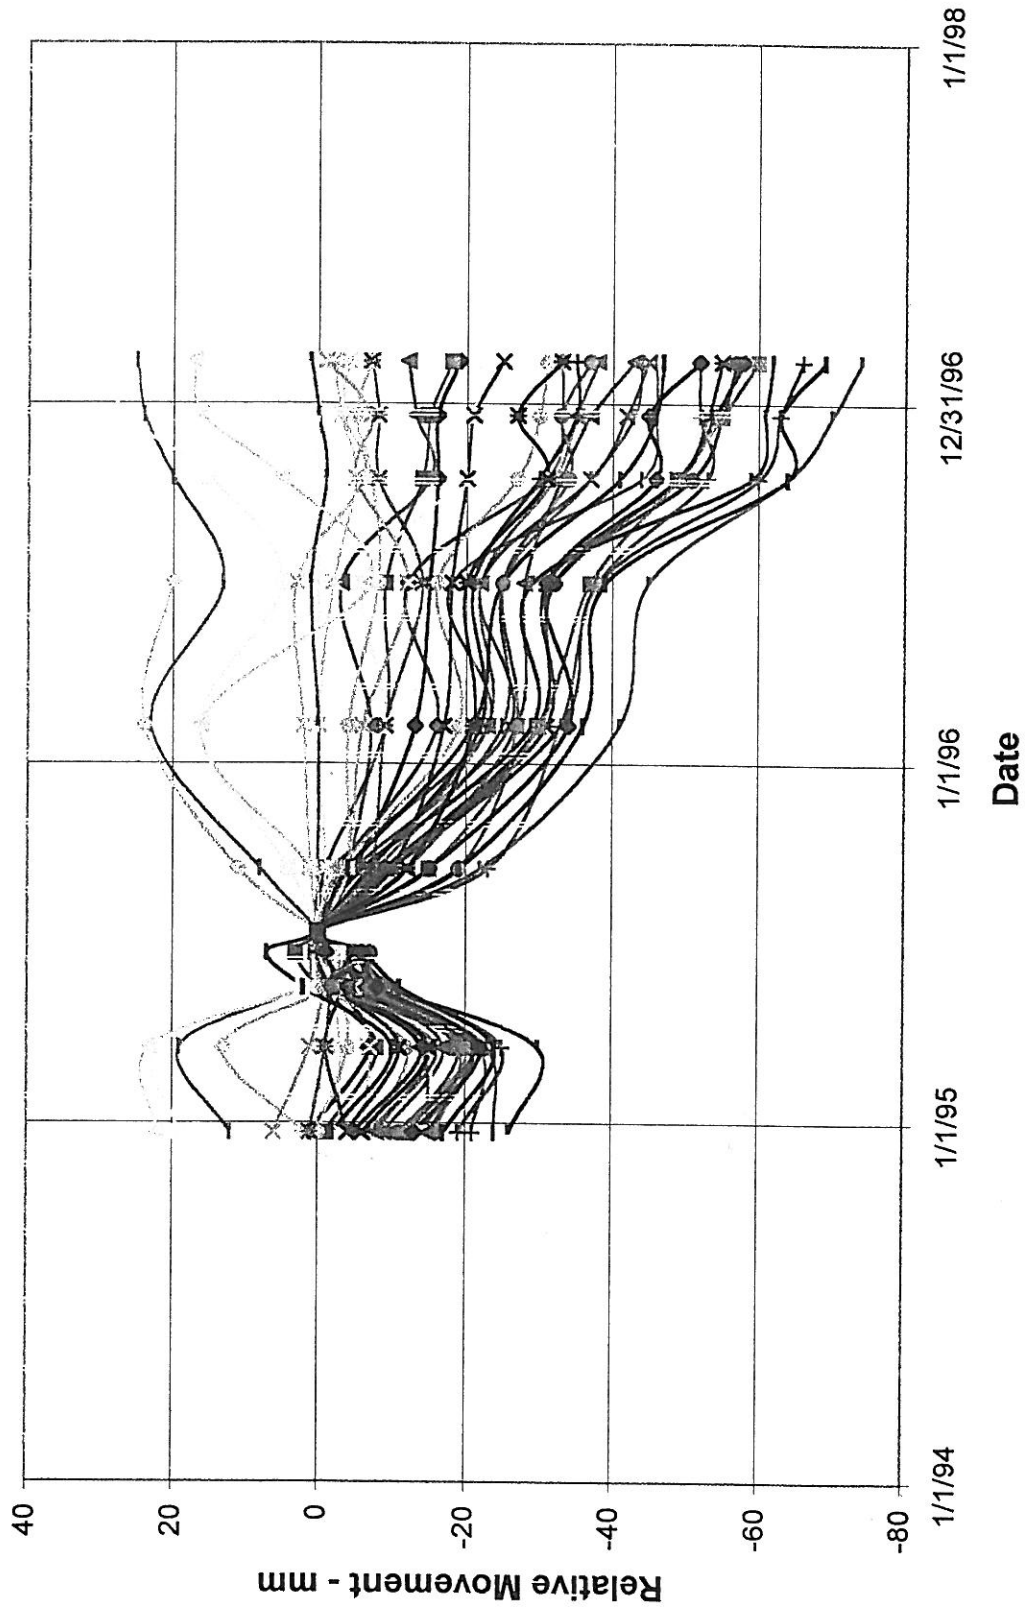
FIGURE 3

There are just over two years of data after the Triodetic foundation was installed and leveled. Figure 3 shows all the data using Point P and July 15, 1995, as reference points. Point P was chosen because this representation seems to show the seasonal differential

From Figure 3, it appears that there was on the order of 20 mm of seasonal differential movement but that there is a progressive differential movement on the order of 50 mm per year. This is an entirely different trend than was observed when the house was on the pile foundation.

It is possible that the gravel pad reduced the frost heave by consolidating the frost susceptible soils, adding load to the frost susceptible soils, and creating better drainage. It is also possible that the addition of the gravel accelerated thawing of the underlying permafrost by reducing the water content of the surficial soils and increasing the surface temperature in the summer.

Regardless of the causes, it is obvious that there is very significant ongoing differential settlement that will require periodic releveled of the house. We see no reason that this trend should change substantially in the near future.

Releveling will require lifting each of the base plates and putting shims or soil under them before lowering them again. It may be possible to lift at key points and shim several points at once. However, if this is done, the resulting foundation will not be level. Cosmetic remedial measures should not be taken without releveling first. If doors or windows are reset, molding is redone, cracks in walls are patched, etc. without releveling, this work will make it more difficult to relevel and be more costly.

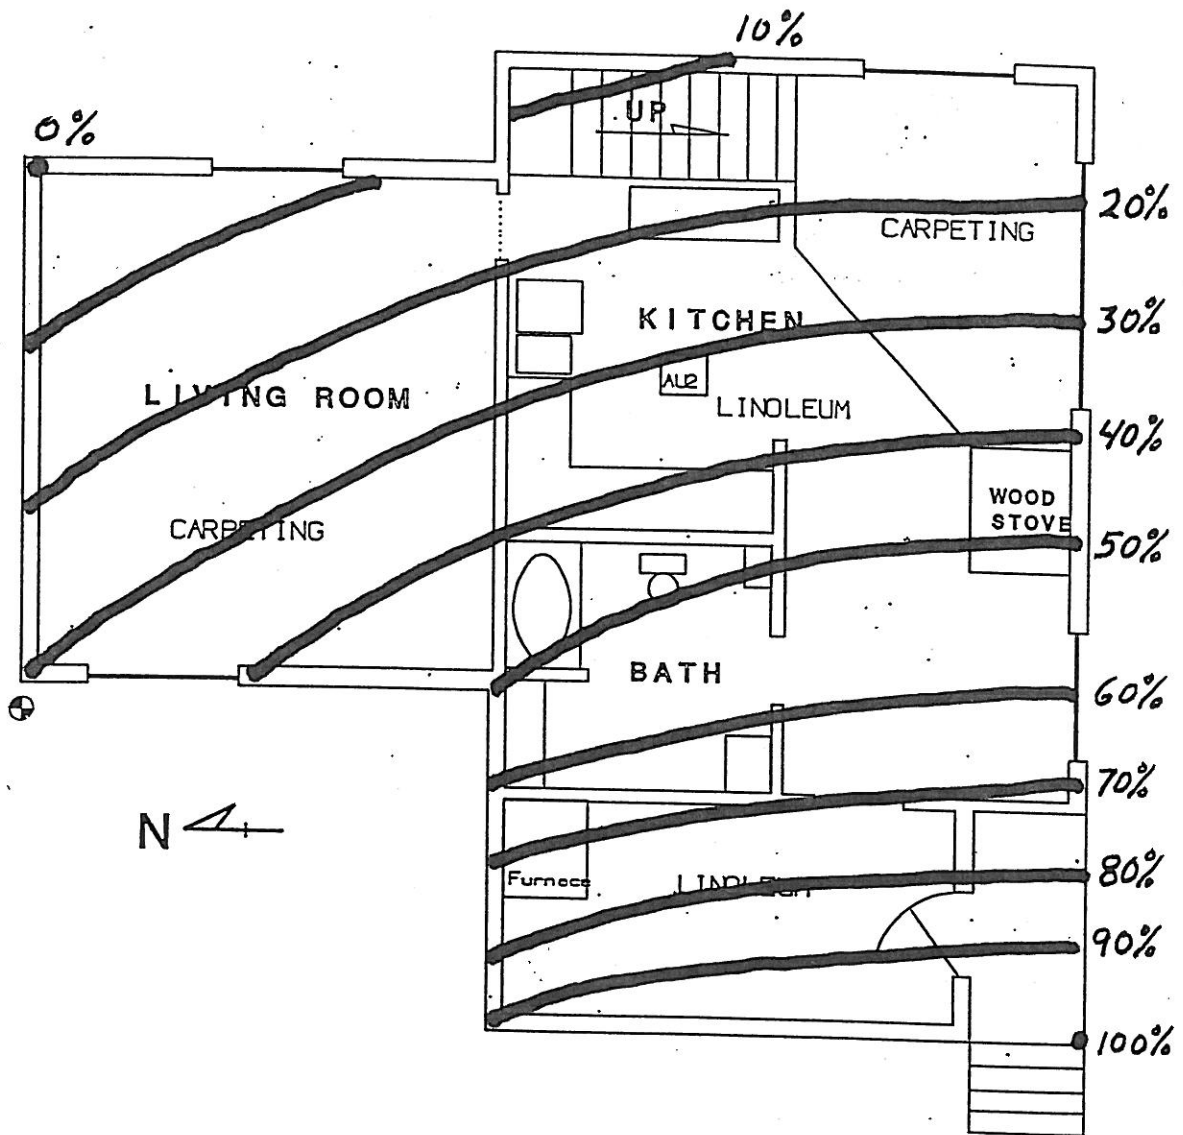
FIGURE 4 – CONTOURS OF DIFFERENTIAL SETTLEMENT OF HOUSE AT 1417 JONES ROAD BETWEEN 10/16/94 AND 2/13/97

The settlement data indicate that the Triodetic foundation is settling differentially at a rate on the order of 50mm (2 inches) per year. The contour map of differential movement across the house shows that it is nearly a plane. This would indicate that a fairly high differential movement could be tolerated before the house must be releveled from a structural standpoint. However, from a functional standpoint the owner may well wish to relevel the house long before it is necessary from a structural standpoint. Assuming the trends observed during the study period continue, it is likely that the house should be releveled for functionality every two to three years.

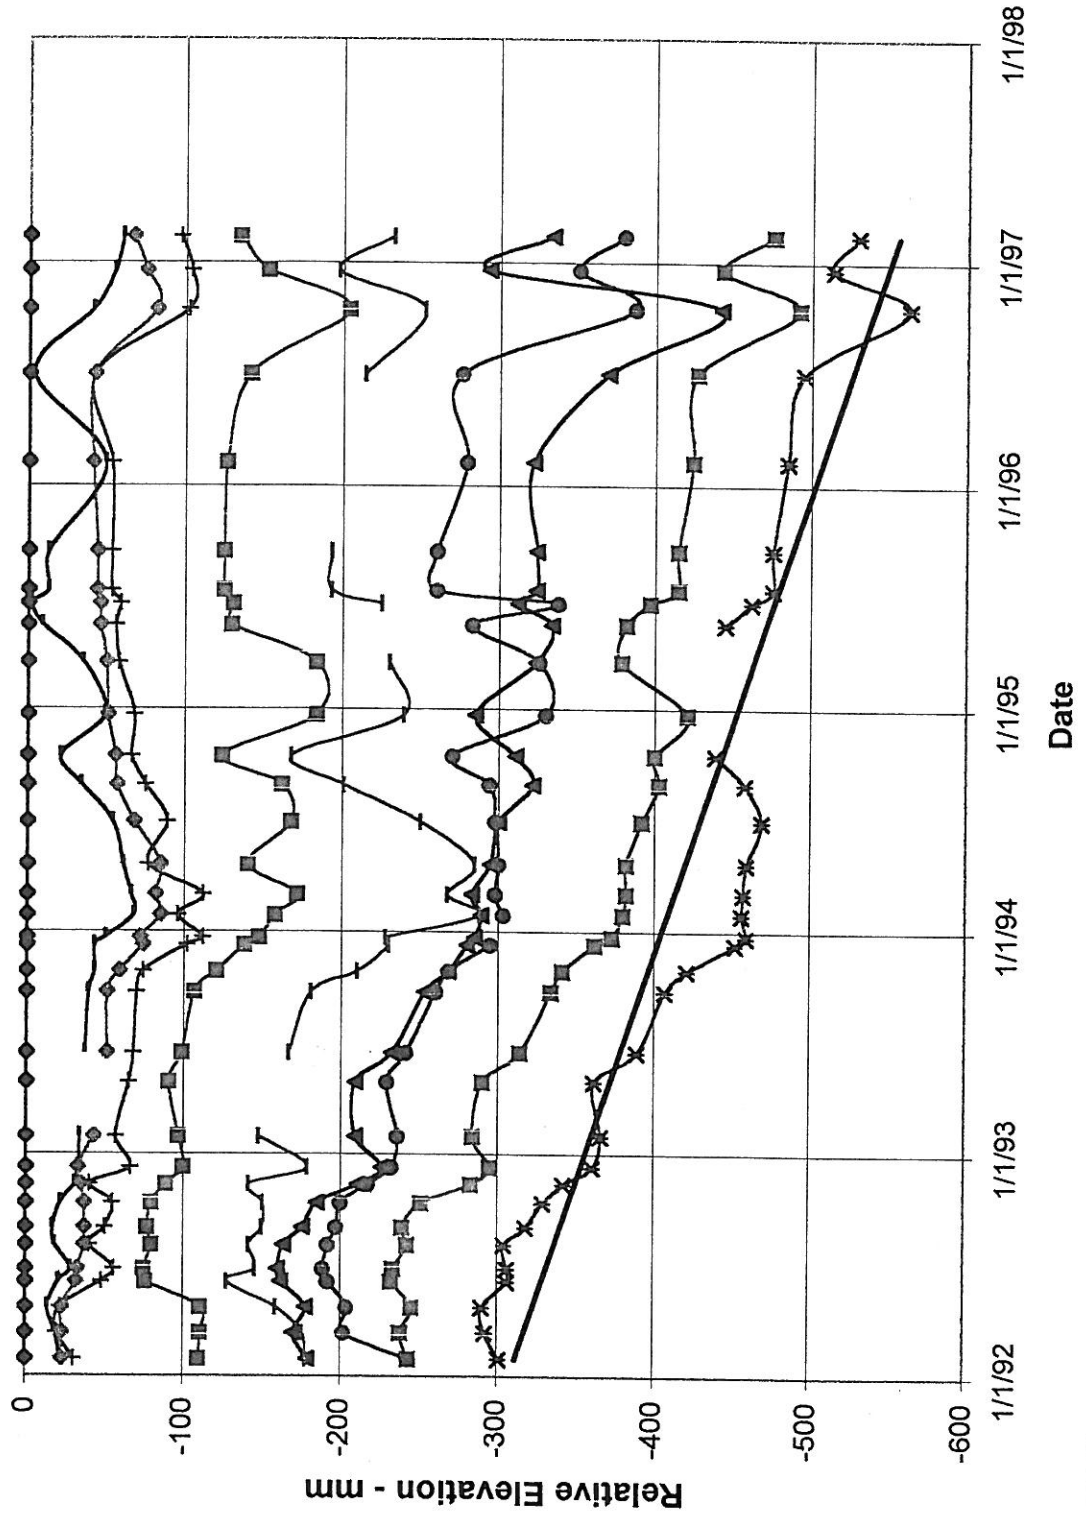
FIGURE 5

Figure 5 shows all the elevation data relative to Point GA. This shows graphically that the garage is over 600 mm out of level and that it is becoming more out of level year by year. It is not obvious from this figure that there is any significant seasonal fluctuation.

In conclusion, the garage was over 550 mm out of level, and that is increasing at a rate of 60 to 70 mm per year. There may be some seasonal differential movement, but it is masked by the large continuing overall movements. There seems to be quite a bit of variability in differential movement from time to time, indicating that, either the rate of thawing, or the subsurface conditions, or both, are not uniform. It is unlikely that the garage is going to reach stability in the near future, indicating that if it is to be saved, remedial action must be done soon.

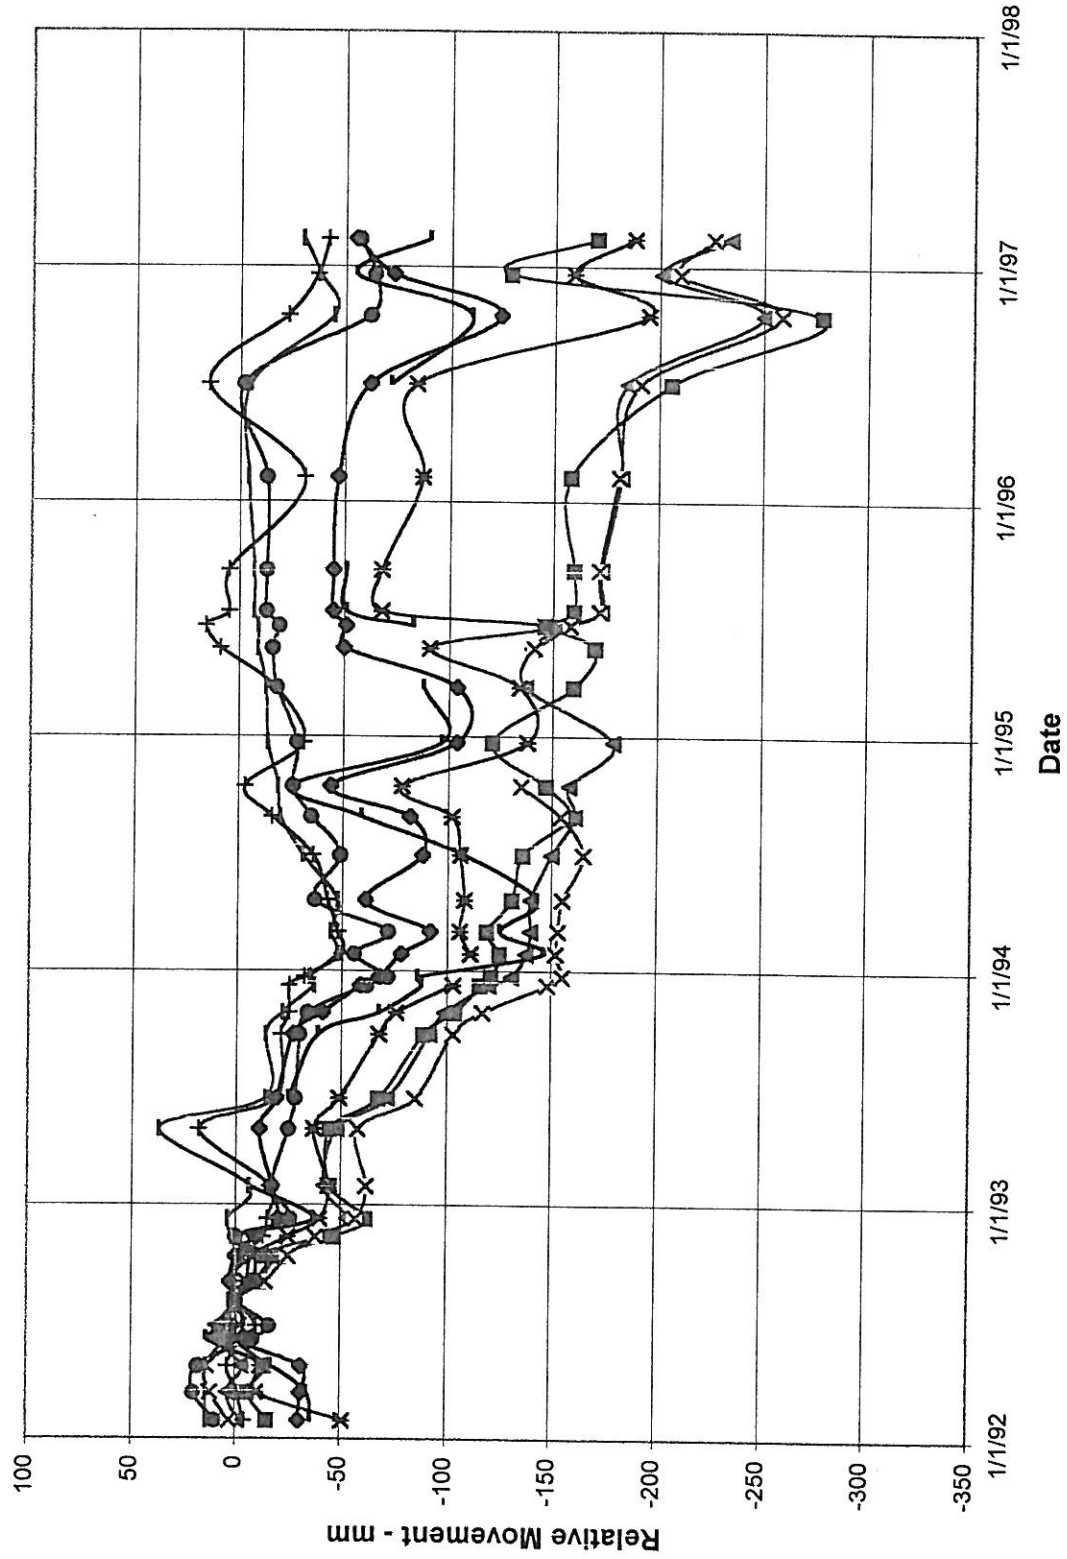
FIGURE 6

Instead, there seems to be very significant differential movement occurring which is somewhat variable from point to point as time progresses.

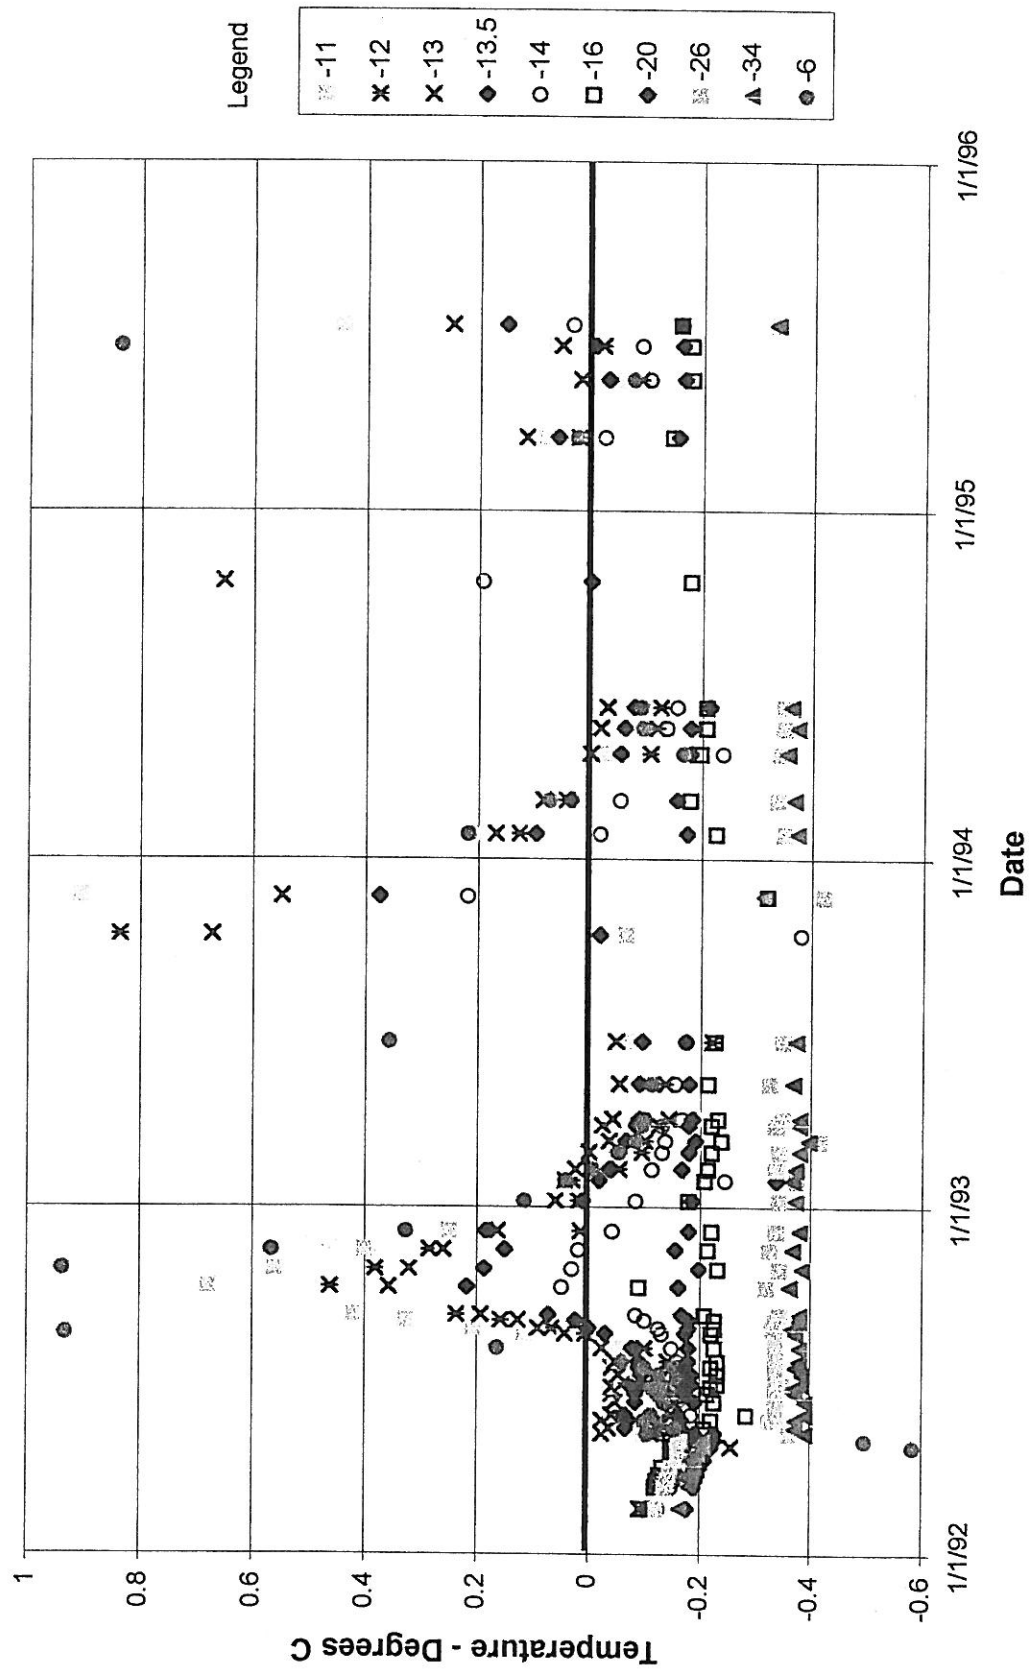
FIGURE 7

- Every thermistor reached a temperature below freezing during the late winter or early spring. This indicates that the active layer touches the permafrost each year.
- Every point above a depth of 14 feet in String 1 and 12.5 feet in String 2 was above freezing in the late summer or fall and below freezing in the late winter. This suggests that the active layer is about 12 to 14 feet deep around the perimeter of the house.
- Temperatures in the permafrost seem to be increasing very slowly, perhaps 0.01 to 0.02 degrees per year. This can be seen in the figures by drawing a line through the data points in late winter for any thermistor. This translates to a slow but steady thawing of the permafrost, perhaps on the order of 75 to 150mm (3 to 6 inches) per year.

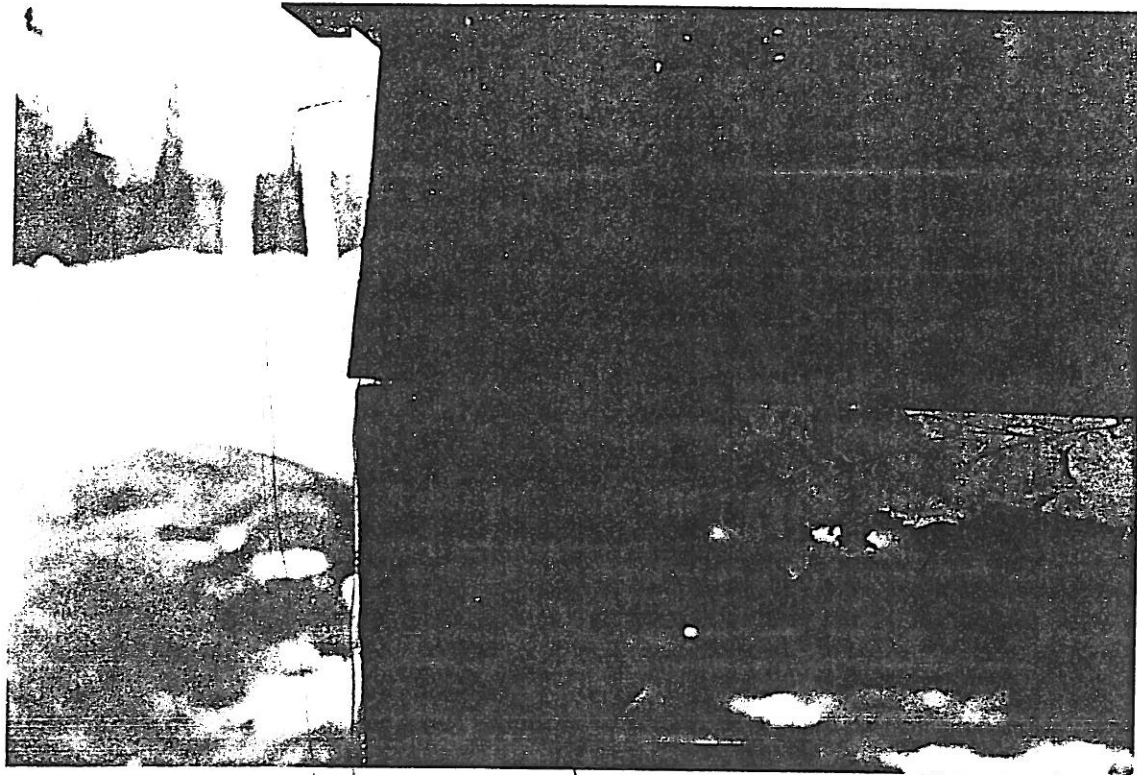
BEAM, JOIST AND RIM JOIST AT THE S.E. CORNER OF THE BUILDING.
JOIST SHOWS CRUSHING DUE TO INSUFFICIENT BEARING AREA.

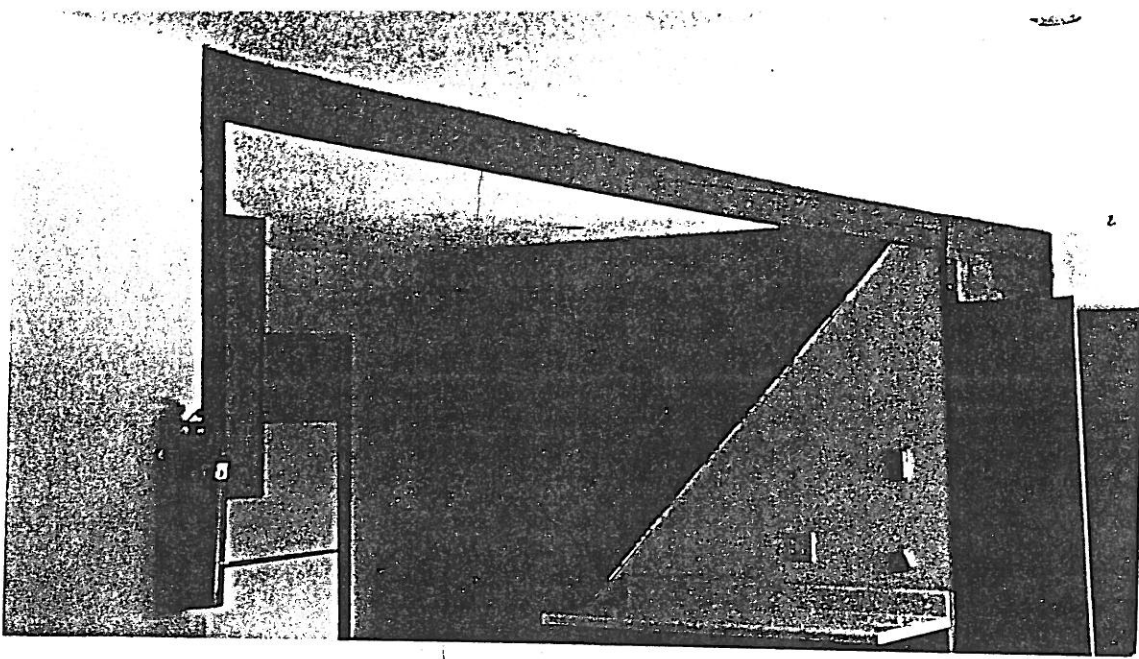
OVERLOADED BEAM IN THE MAIN AREA

Some type of added support at mid-span for the overstressed beams would only add to the differential settling and periodic leveling problems; therefore, we recommend replacing the beams under the main living area with three 1-3/4"x11-7/8"s microlams continuous from support to support. Lateral support shall be provided with the installation of five 2"x12"s installed from beam to beam. The bedroom addition would need four 2"x10"s installed from beam to beam. See the attached drawing showing the minimum bearing areas for each load point. Uplift restraint should be provided by 3/4" plywood nailed to the joist, rim joists and the beam for the entire length. Replace the existing beam-piling ties with a flat steel plate 1/8" thick. Each plate should be bolted with 1/2" bolts, a total of 4 per connection. Only the main living area and the bedroom addition need this connection (19 connections). Notch the piling as necessary for this connection.
