FINAL REPORT

FOUNDATION STABILIZATION RESEARCH
STUDIES at

263 Madcap Lane

March 1999

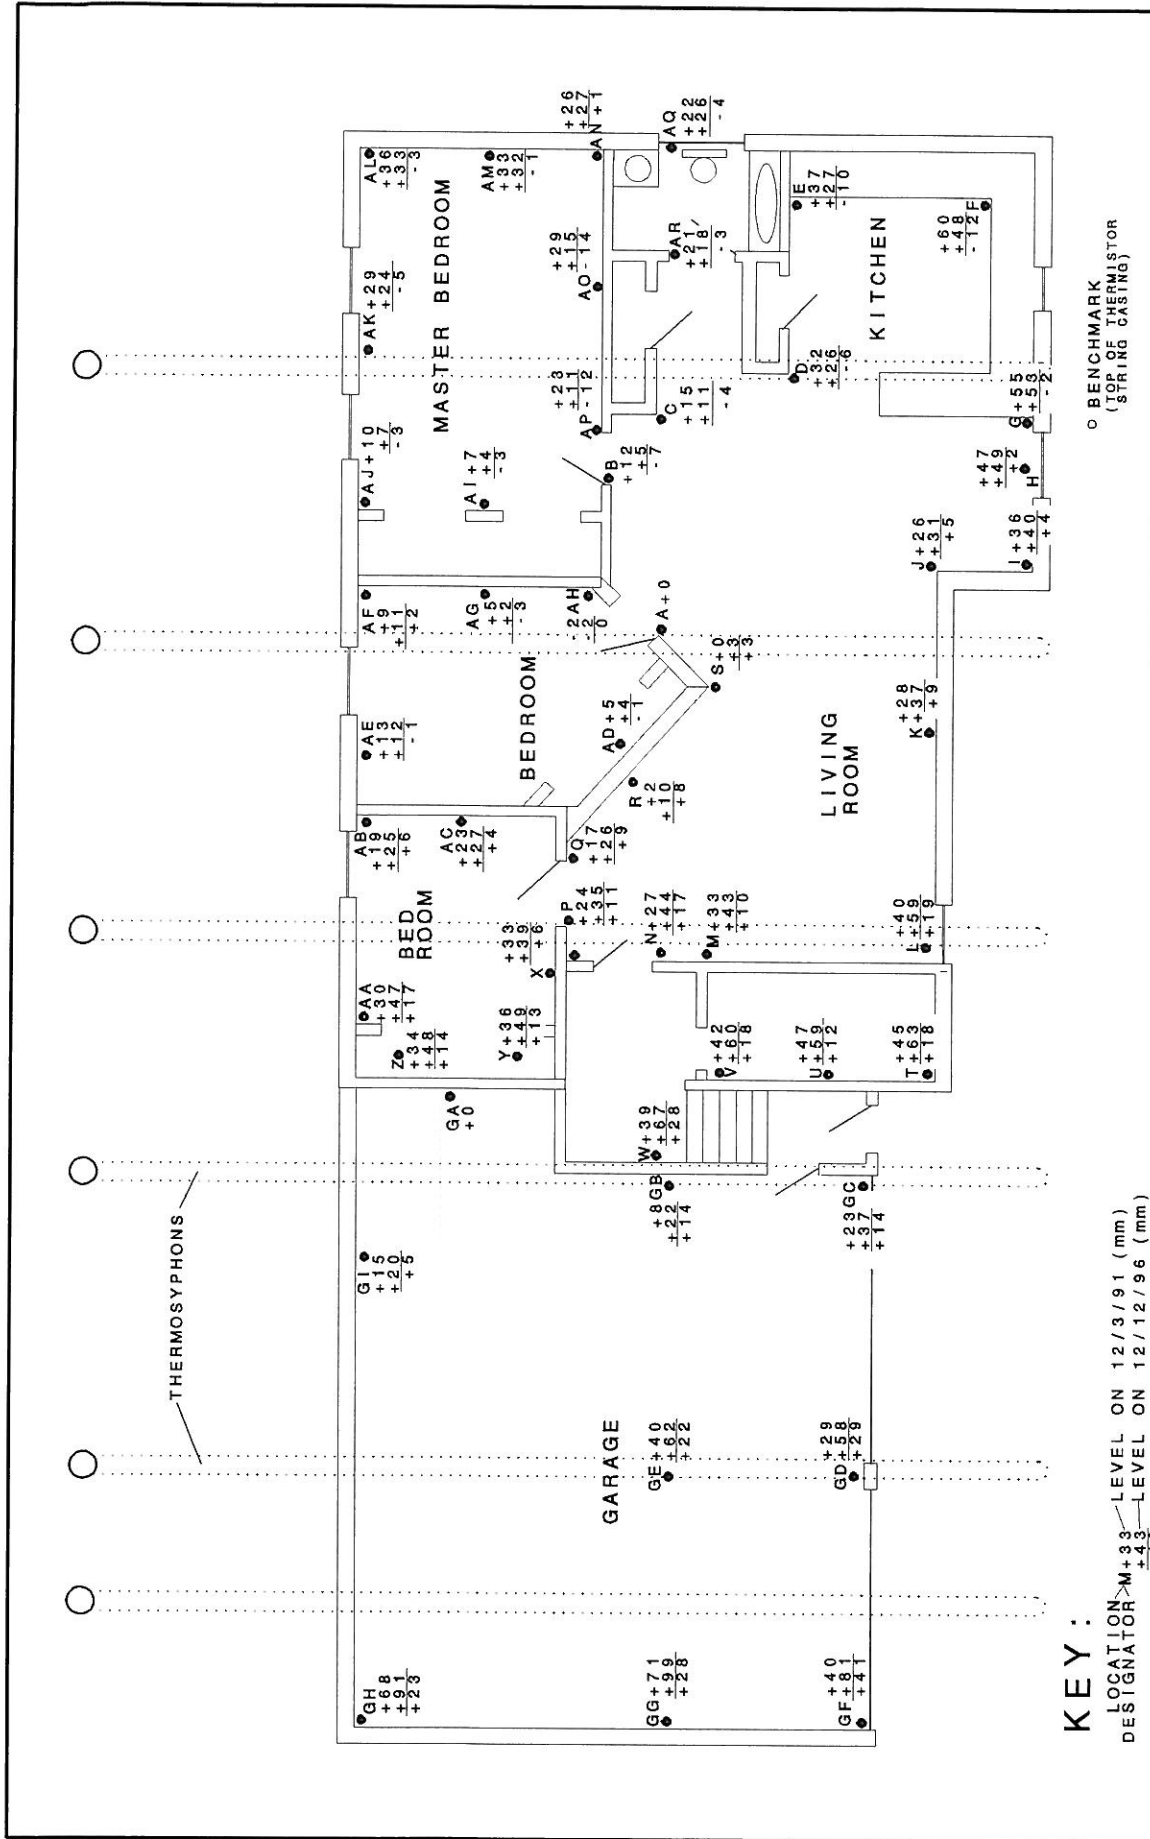
PERMAFROST TECHNOLOGY FOUNDATION
 263 MADCAP LN. FAIRBANKS, AK
 DIFFERENTIAL ELEVATIONS ON THE BASEMENT AND GARAGE FLOOR OVER 5 YEARS OF DATA ACCUMULATION
 FIG. 8

The garage floor slab may have heaved. Figures 8 and 9 show the differential elevation of numerous monitoring points at various times during the seven year experiment. By 1999 the northeast corner (pt. GF) had risen 66 mm (2.6 in.) with respect to point GA (Fig. 9). The garage and the basement use different reference points so the two levels cannot be compared except to note that there is a general upward slope from the north wall towards the south wall of each level (figures 10, 11 and 12). It must be kept in mind that this differential could also be a combination of subsidence of the north portion of the house combined with heaving of the south portion. Without a reliable outside reference benchmark (which is not available in the area), and an initial measurement between that benchmark and point A, it is difficult to resolve the question of heaving vs. settling. However, when elevations along the walls are considered together as a set, it is significant that as the distance from point A increases, the elevation of the point increases in all cases. This is not characteristic of frost heaving which would be expected to show up as irregular increases in elevation in the vicinity of the thermosyphons. The selective elevation increase directly correlated with distance from point A (which is near the center of the basement and therefore subject to the greatest thaw depth beneath it) and suggests subsidence in the central portion of the slab near where point A is located.

Figures 8 through 12 show a gradual trend of continual differential elevation change from the north to the south side of the house, and in the seven years of data record the elevation change has accumulated enough to cause some minor problems with the usability of the house. Doors in the basement apartment at points A and P are binding because the door jamb is no longer perfectly square. This is easily correctable, but it does confirm an unresolved problem with differential movement. It would normally be expected that if settlement due to thawing permafrost were occurring, that the south and especially the southwest corner of the house would settle first and to the greatest degree. However, this is not the case since the only point showing a negative elevation change is at point AH which is very near point A in the northern third of the structure. A possible explanation may be as follows: the deepest portion of the thaw bulb beneath the house should be near the center of the heated basement slab. Assuming that the cooling effect of the thermosyphon in this region was equal to the others, then it would require more time for this thermosyphon to build a large enough frost bulb to stop the subsidence into the thawed (and very soupy soil, see figure 2) soils. The thermosyphons under the rest of the house have a shallower thaw depth to deal with and may have stabilized or even heaved the soil in their vicinity. This would suggest that the garage slab would show more elevation increase than the basement slab since it is both closer to the surface and somewhat cooler than the heated apartment. Figures 8, 9 and 12 confirm that the greatest elevation increase has been in the garage points which are farthest from point A.

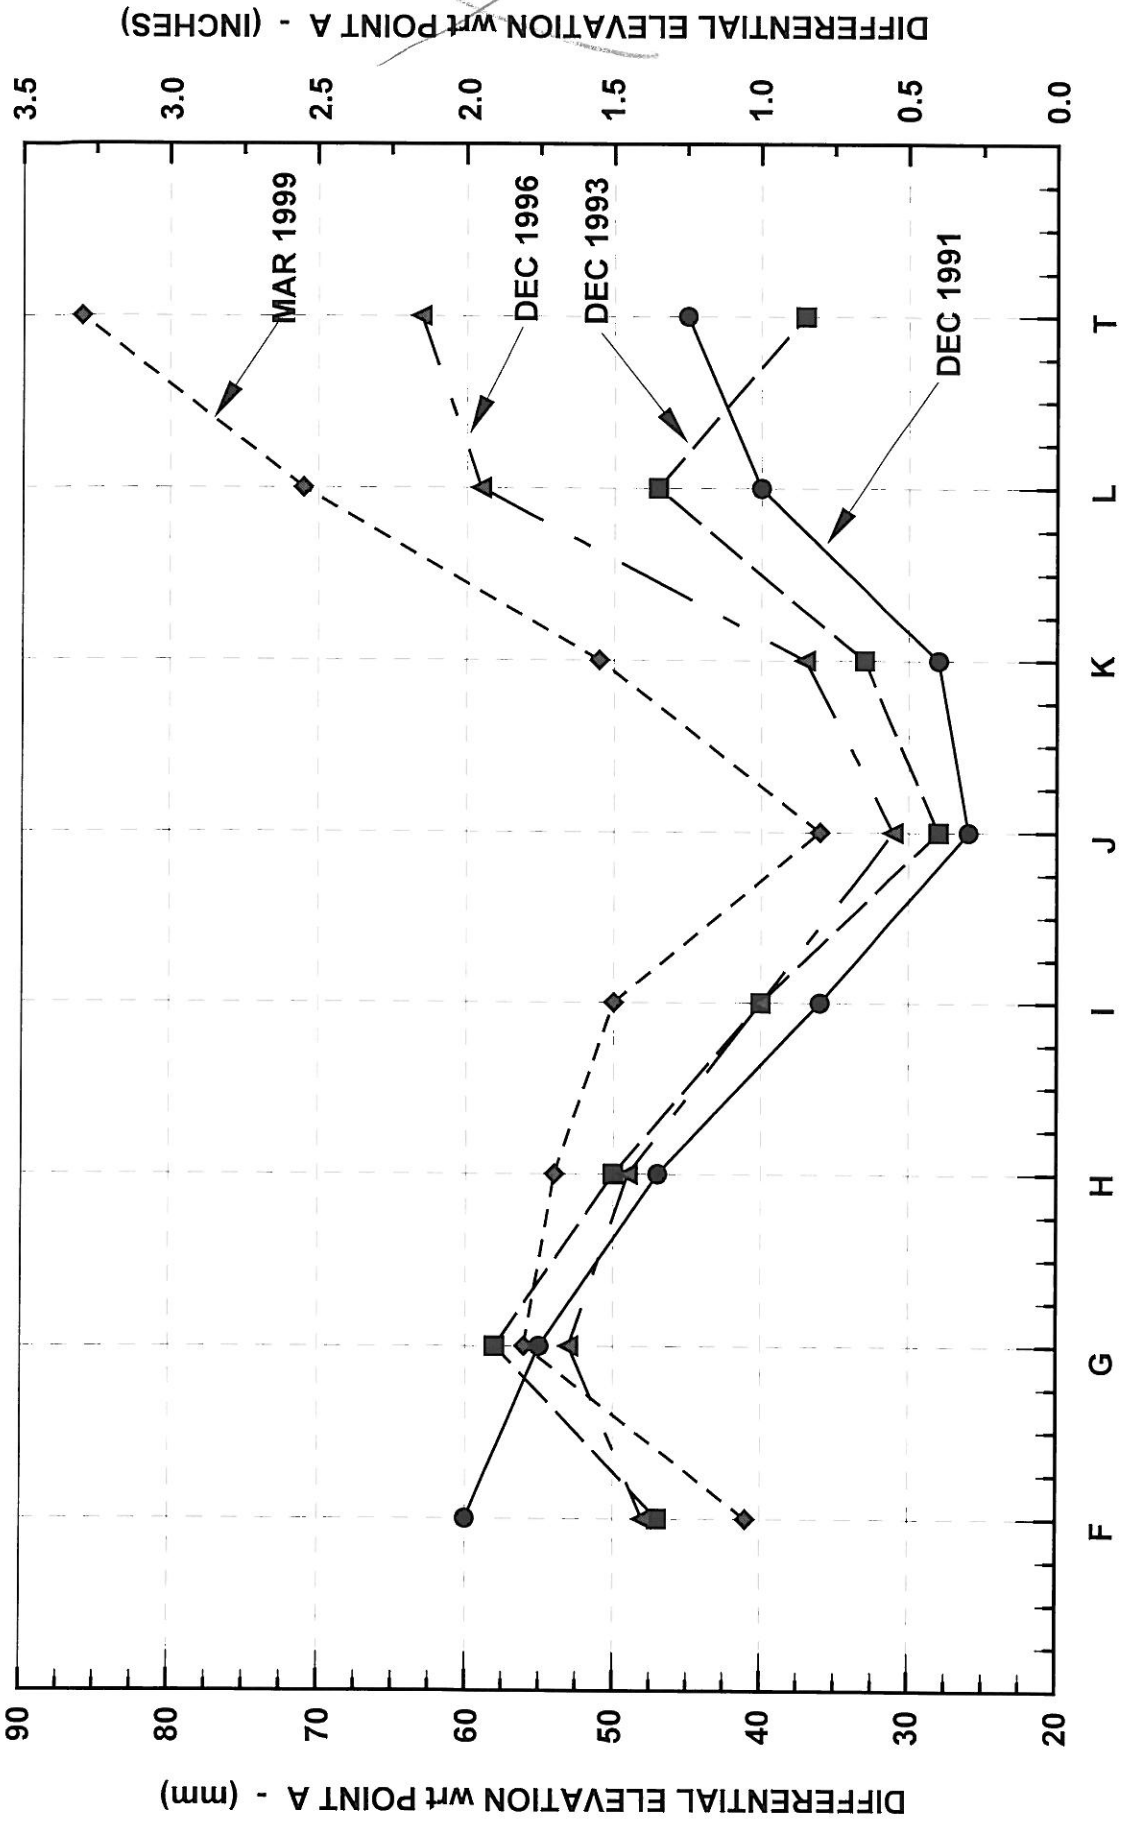
FIGURE 11 - ELEVATION VS TIME ALONG EAST WALL

level, a differential elevation change of 40 mm (1.6 inches) is found on the landing at the bottom of the stairs. The floor along the east wall of the basement (the living room area) shows a differential elevation change with respect to point A that varies from -19mm (0.75 inches) in the northeast corner of the kitchen (point F) to + 31 mm (1.2 inches) in the southeast corner of the living room (point L).

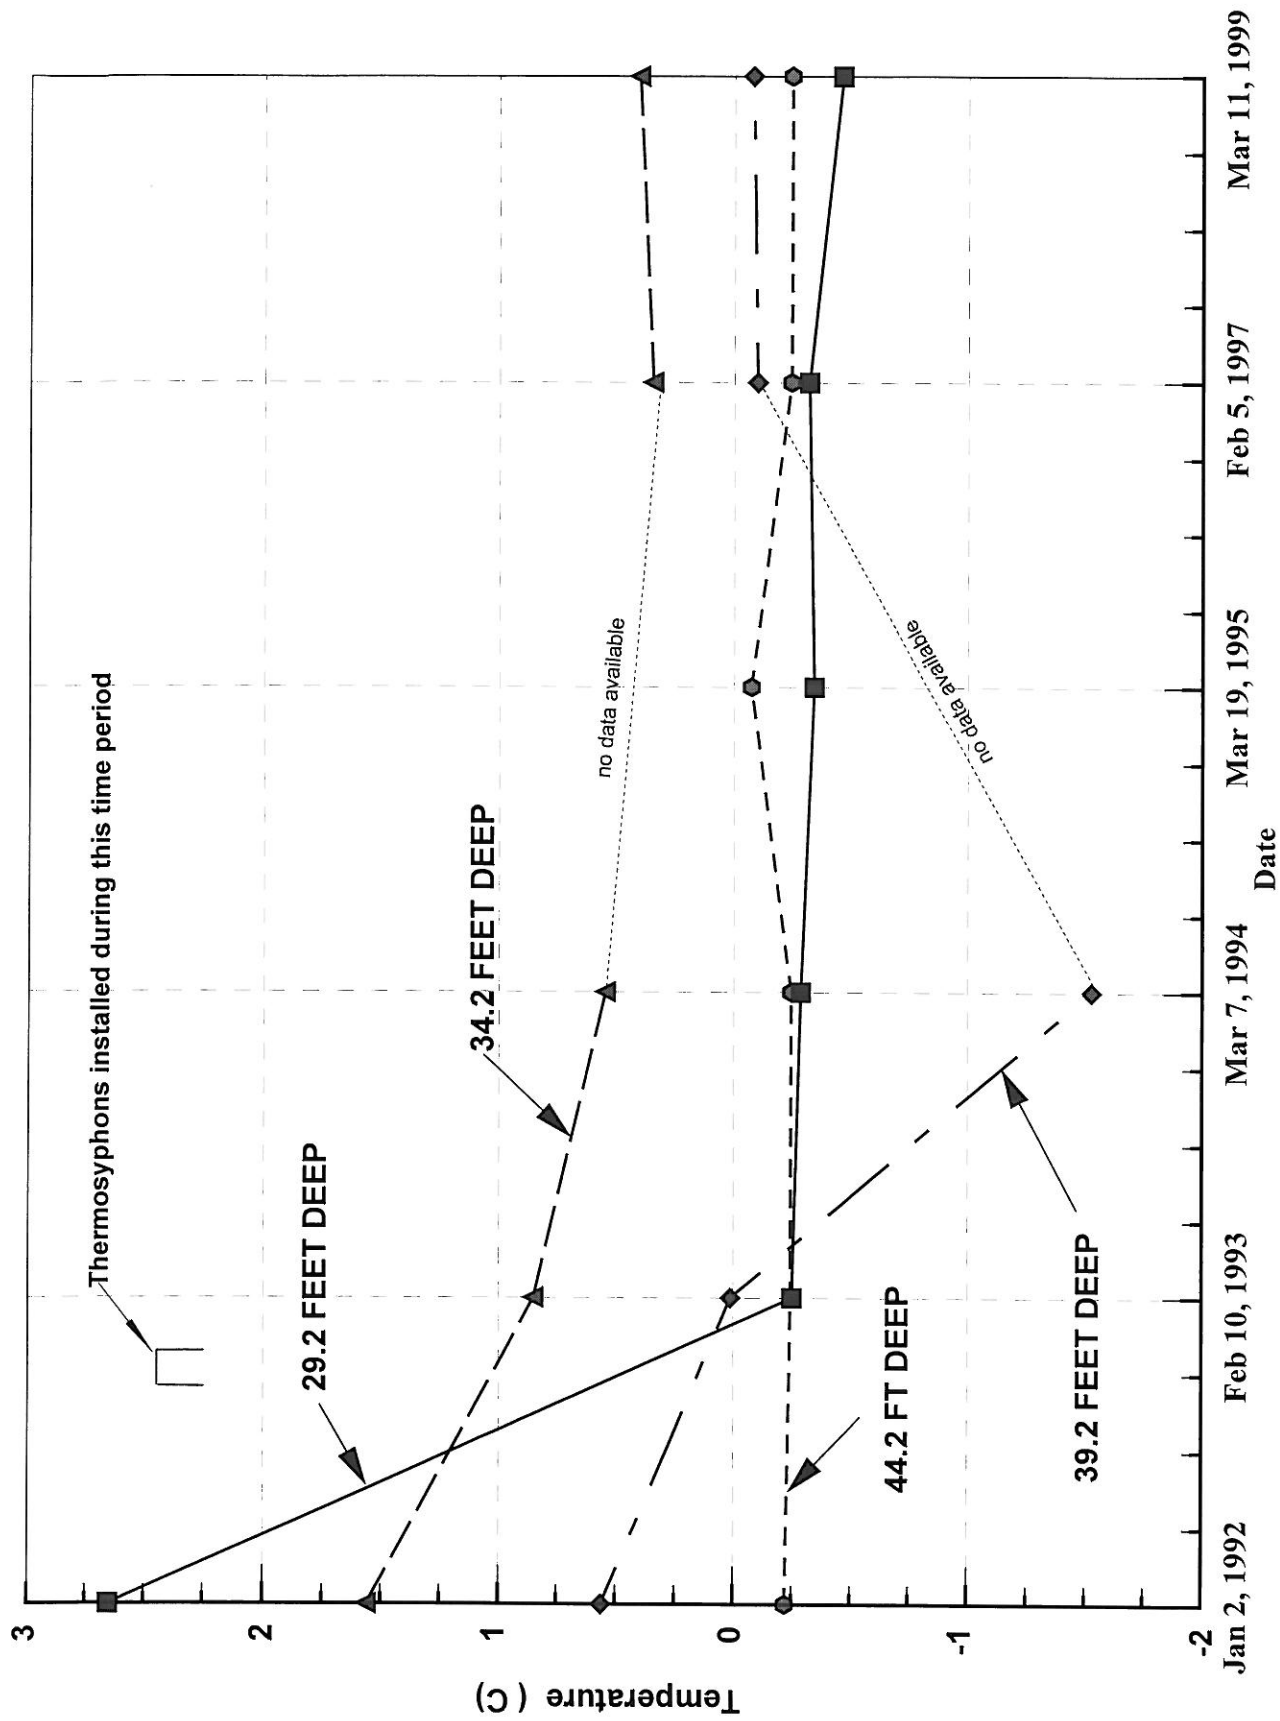
FIGURE 13 - TEMPERATURES AT TEPH - THERMISTOR sTRING 3 vs DATE

The thermal influence of the thermosyphons can be seen in the data from thermistor strings no. 3 and no. 4 which are buried under the floor slab in the basement (fig. 7). figures 16 and 17 show plots of temperature vs. depth at various times during the experiment. The general depth of the thermosyphon can be seen in each plot as the locally depressed temperature at approximately 29 feet at the east wall of the house (thermistor string 3, thermosyphon 5), and at approximately 14 feet deep in the center of the house (thermistor string 4, thermosyphon 5). This data along with the pressure measurements at the end of the experiment confirm that the thermosyphons are performing as they should and are not only intercepting heat entering the soil beneath the house, they have stopped further melting of the permafrost. However the continued mild subsidence (if that conclusion is correct) suggests that more cooling power is required under the center of the basement.

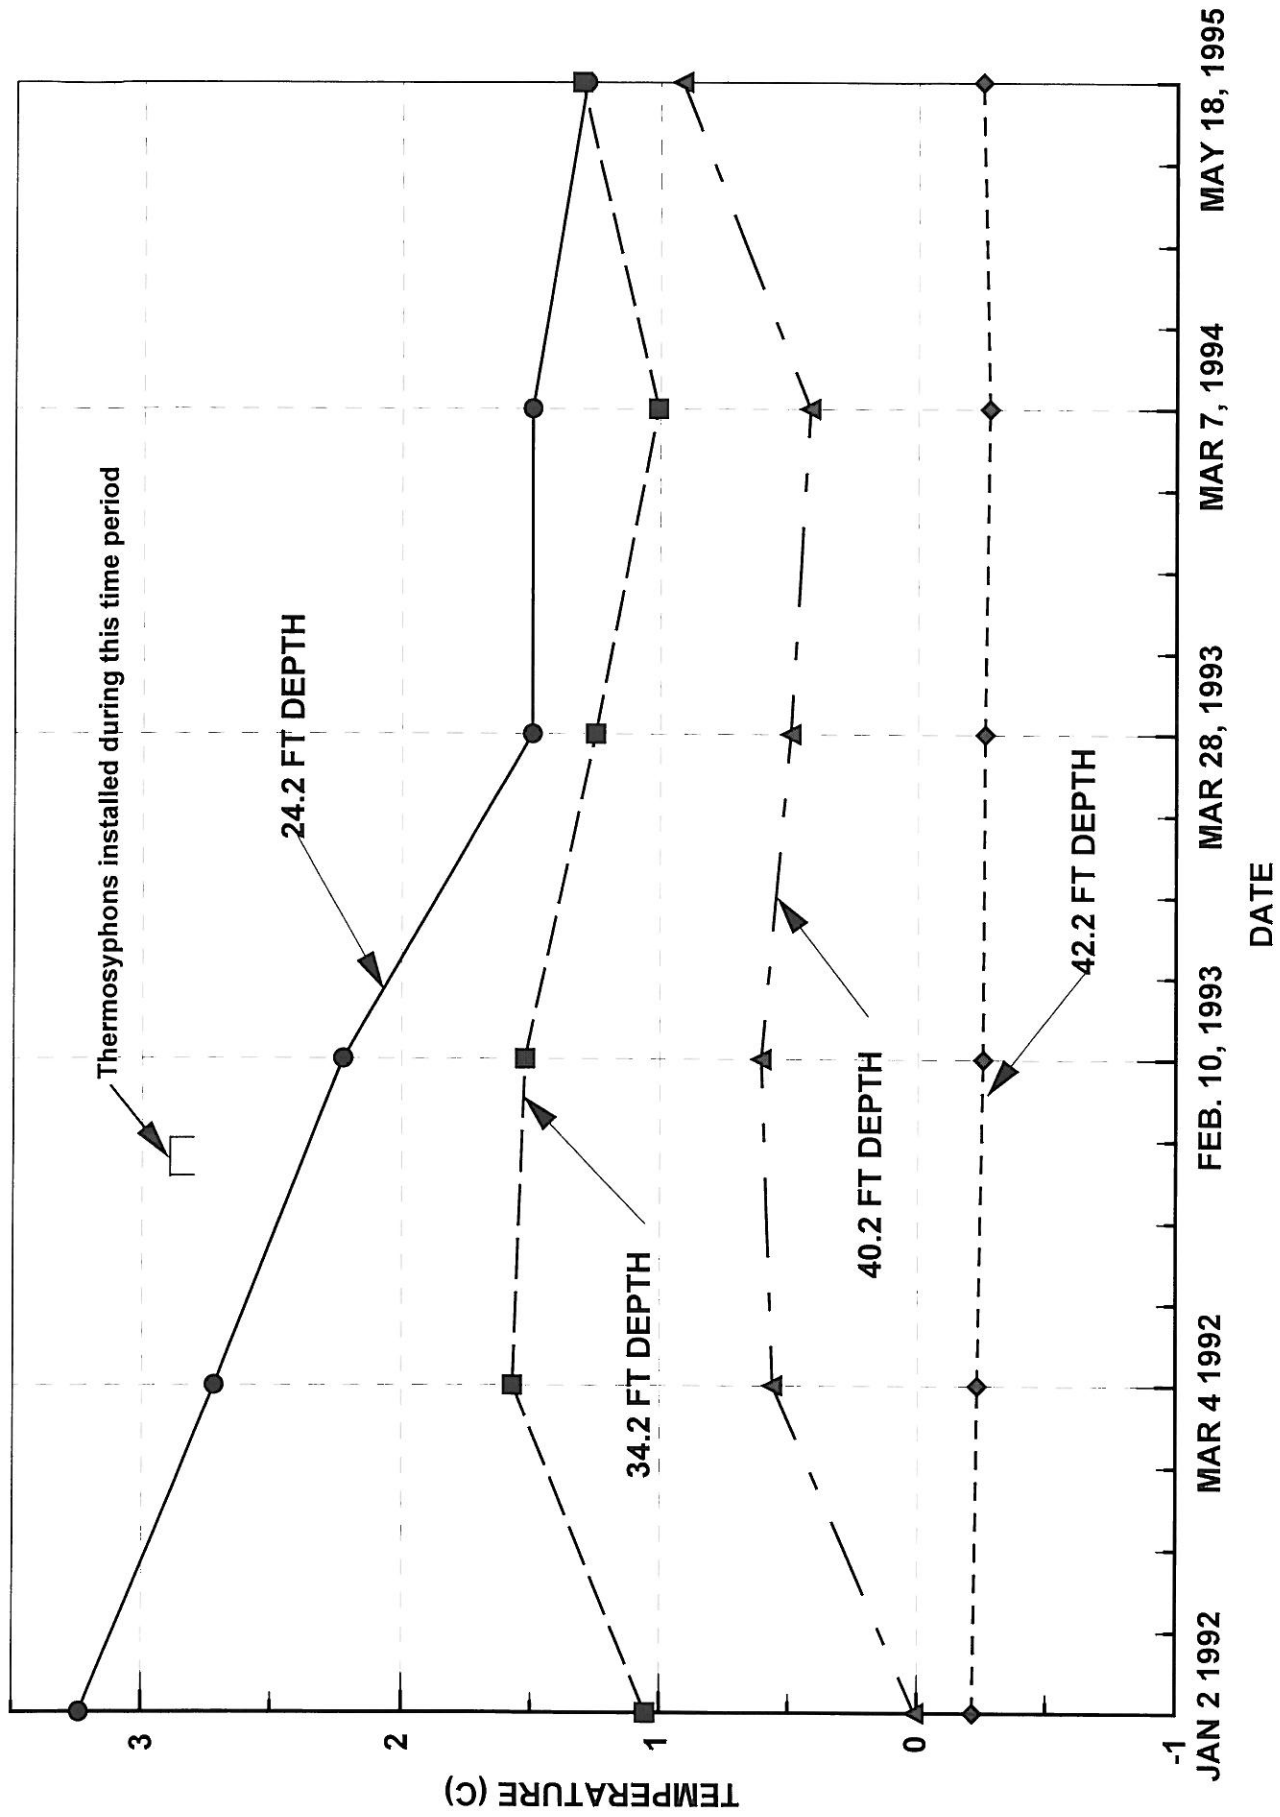
FIGURE 14 - TEMPERATURES AT DEPTH - THERMISTOR STRING 4 vs DATE

Temperature data from thermistor string 4 (figure 14) which is under the center of the basement floor slab of the house (see fig. 7) show a steady decline in temperatures beneath the floor (after the thermosyphon installation) until sometime between March 1994 and May 1995 at which time temperatures begin a slight rise. Unfortunately thermistor string 4 ceased operating after May 1995 so no further data is available. Thermistor string 3 (figure 13) which is centered along the east wall of the basement (see fig. 7) shows a very small temperature rise, above the permafrost, but not until after February 1997. Conversely temperatures from thermistor string 2 (figure 15) which is on the southwest end of the building (fig. 7) show a continual decline for the entire period after the thermosyphons were installed in the fall of 1992. This data gives support to the theory of a combination of settlement under the center of the house and heaving at each end.

An additional thermosyphon placed between numbers 4 and 5 could bridge the wide spacing that resulted during installation and increase the cooling power. This requires that a directional drilling team be brought in to install the evaporator section of the new thermosyphon.

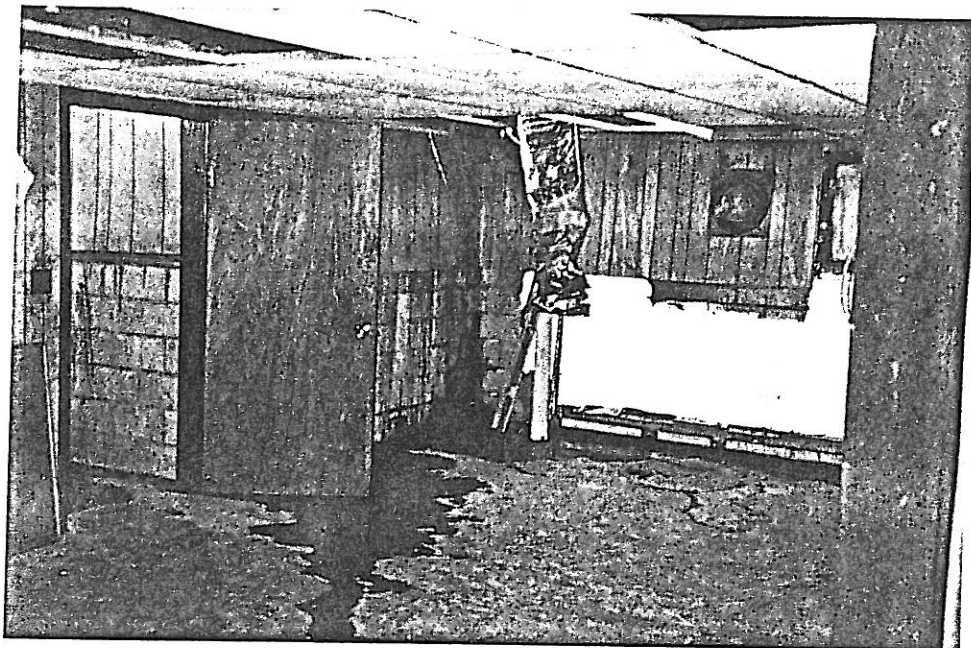
The actual entry point of the water was not found but the water appears to be coming into the basement from along the base of the west foundation wall and the southwest corner of the basement open area. This portion of the foundation is on the Farmers Loop Road side of the structure and a general inspection of the exterior surface drainage indicates that poor drainage away from the building maybe the cause of the water problem.

PHOTO #8: BASEMENT AREA; THE UNFINISHED PORTION ACCESS DOOR IS AT LEFT, POSSIBLE POINT OF WATER ENTRY IS AT THE FAR CORNER OF THE BLOCK FOUNDATION WALL.

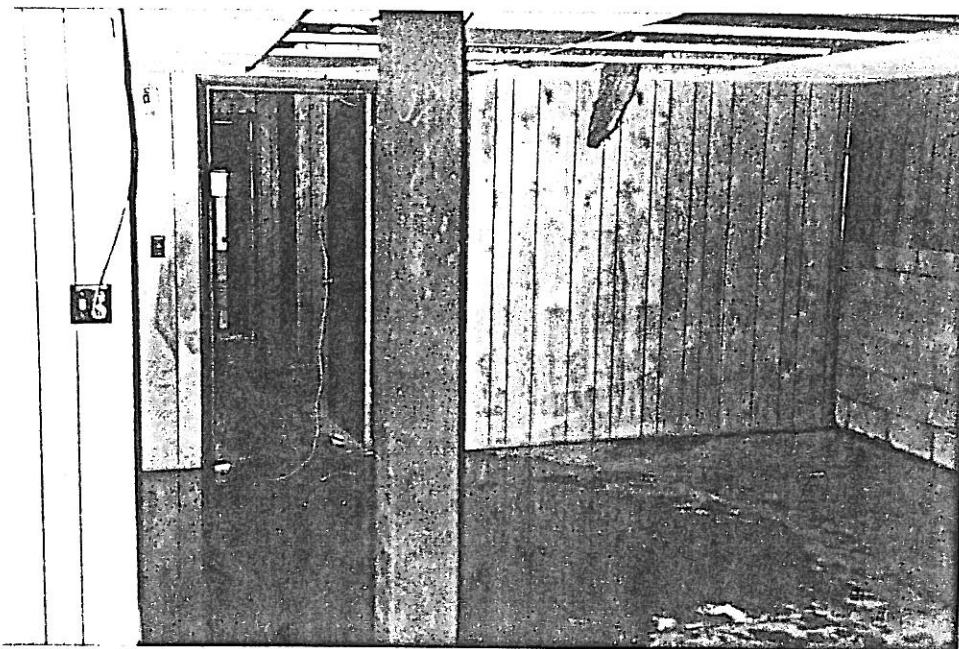
PHOTO #9: BASEMENT AREA; DOORWAY IN BACKGROUND IS TO THE APARTMENT UNIT, STANDING WATER ON FLOOR SURFACE, PHOTO TAKEN FROM ENTRY DOOR TO BASEMENT.

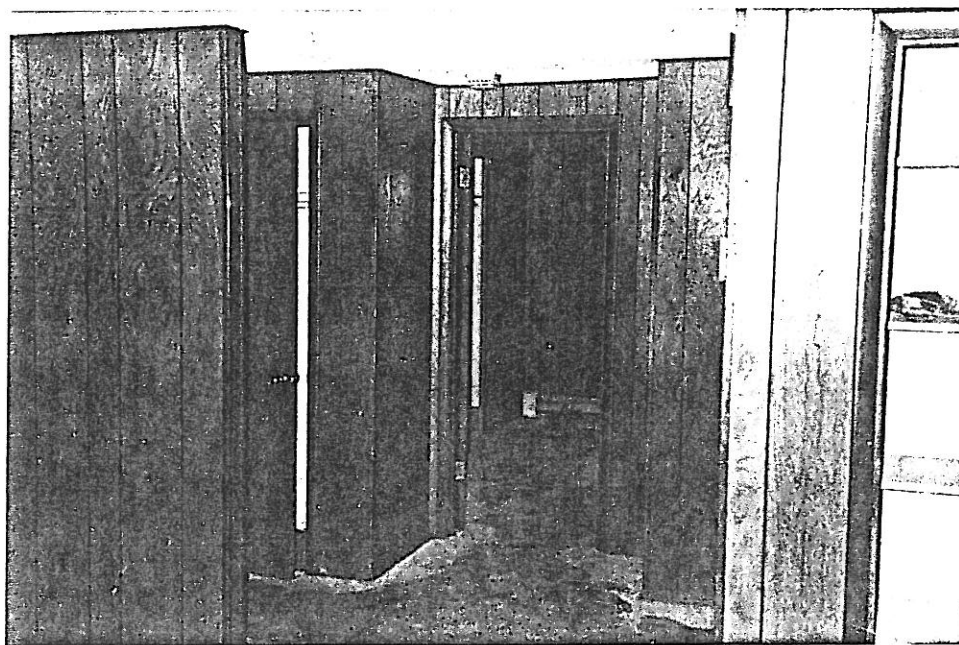
PHOTO #11: BASEMENT APARTMENT; HALLWAY AND BEDROOM AREA, CARPET IS WATER SOAKED IN THESE AREAS. PHOTO TAKEN FROM LIVING ROOM AREA.

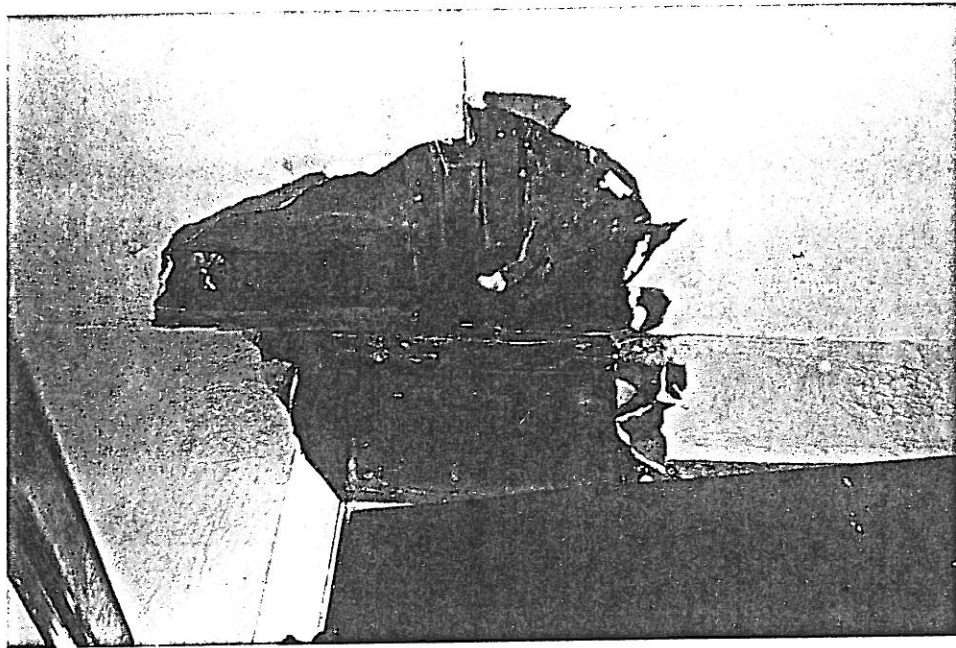
PHOTO #12: BASEMENT BATHROOM; THE EXISTING WATER DAMAGE AND ROTTING ON THE BATHROOM CEILING.

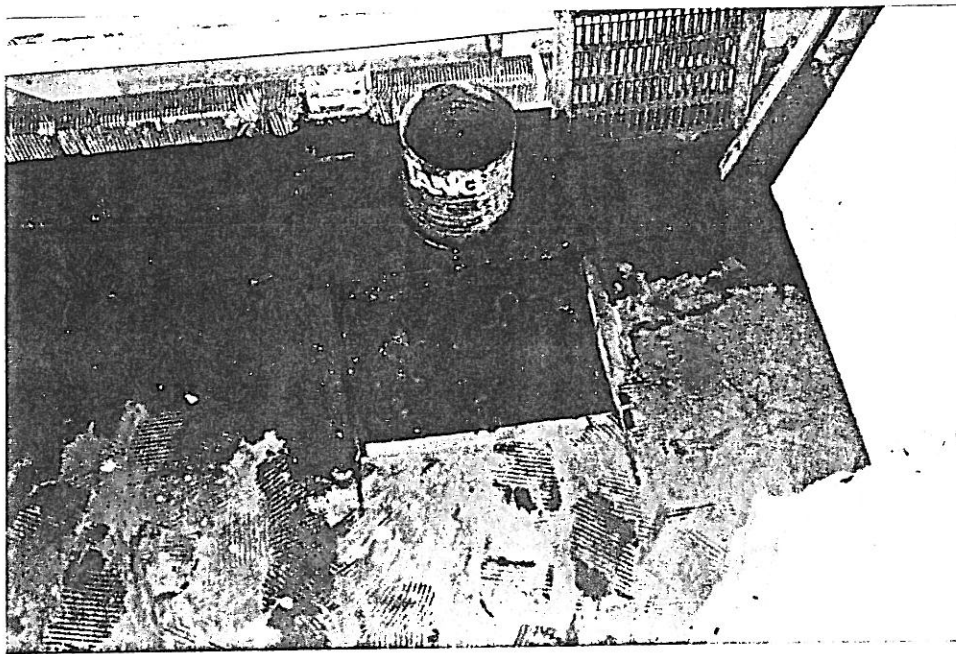
PHOTO #13: BASEMENT AREA; AN EXISTING HOLE CUT INTO THE BASEMENT FLOOR SLAB, SUMP AREA?, ONLY SEVERAL INCHES DEEP.

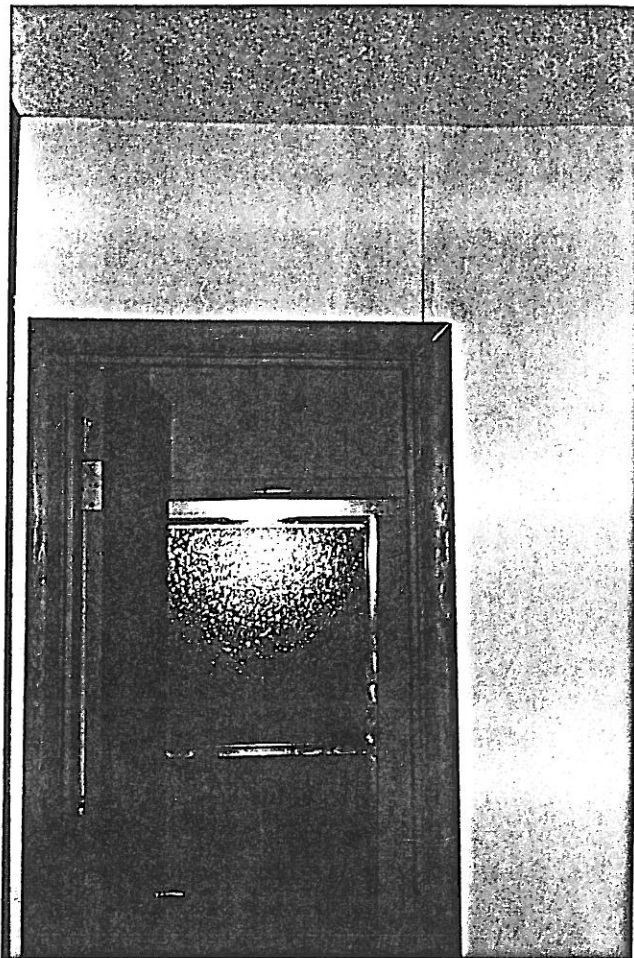
PHOTO #16: FIRST
FLOOR MASTER BED-
ROOM; EXISTING
SHEETROCK CRACK ON
THE WALL AT THE
DOORWAY TO BATHROOM.
