PERMAFROST
TECHNOLOGY
FOUNDATION

FINAL REPORT

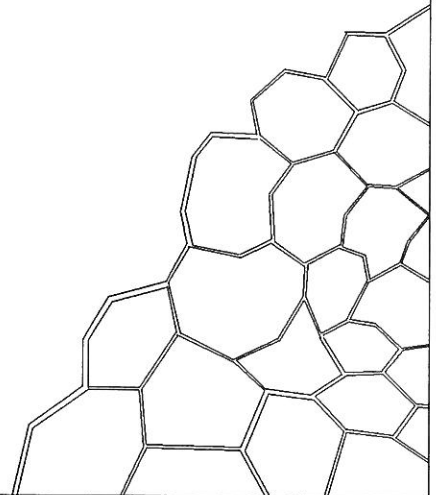
Final Report
on
Foundation Stabilization Research
Studies on

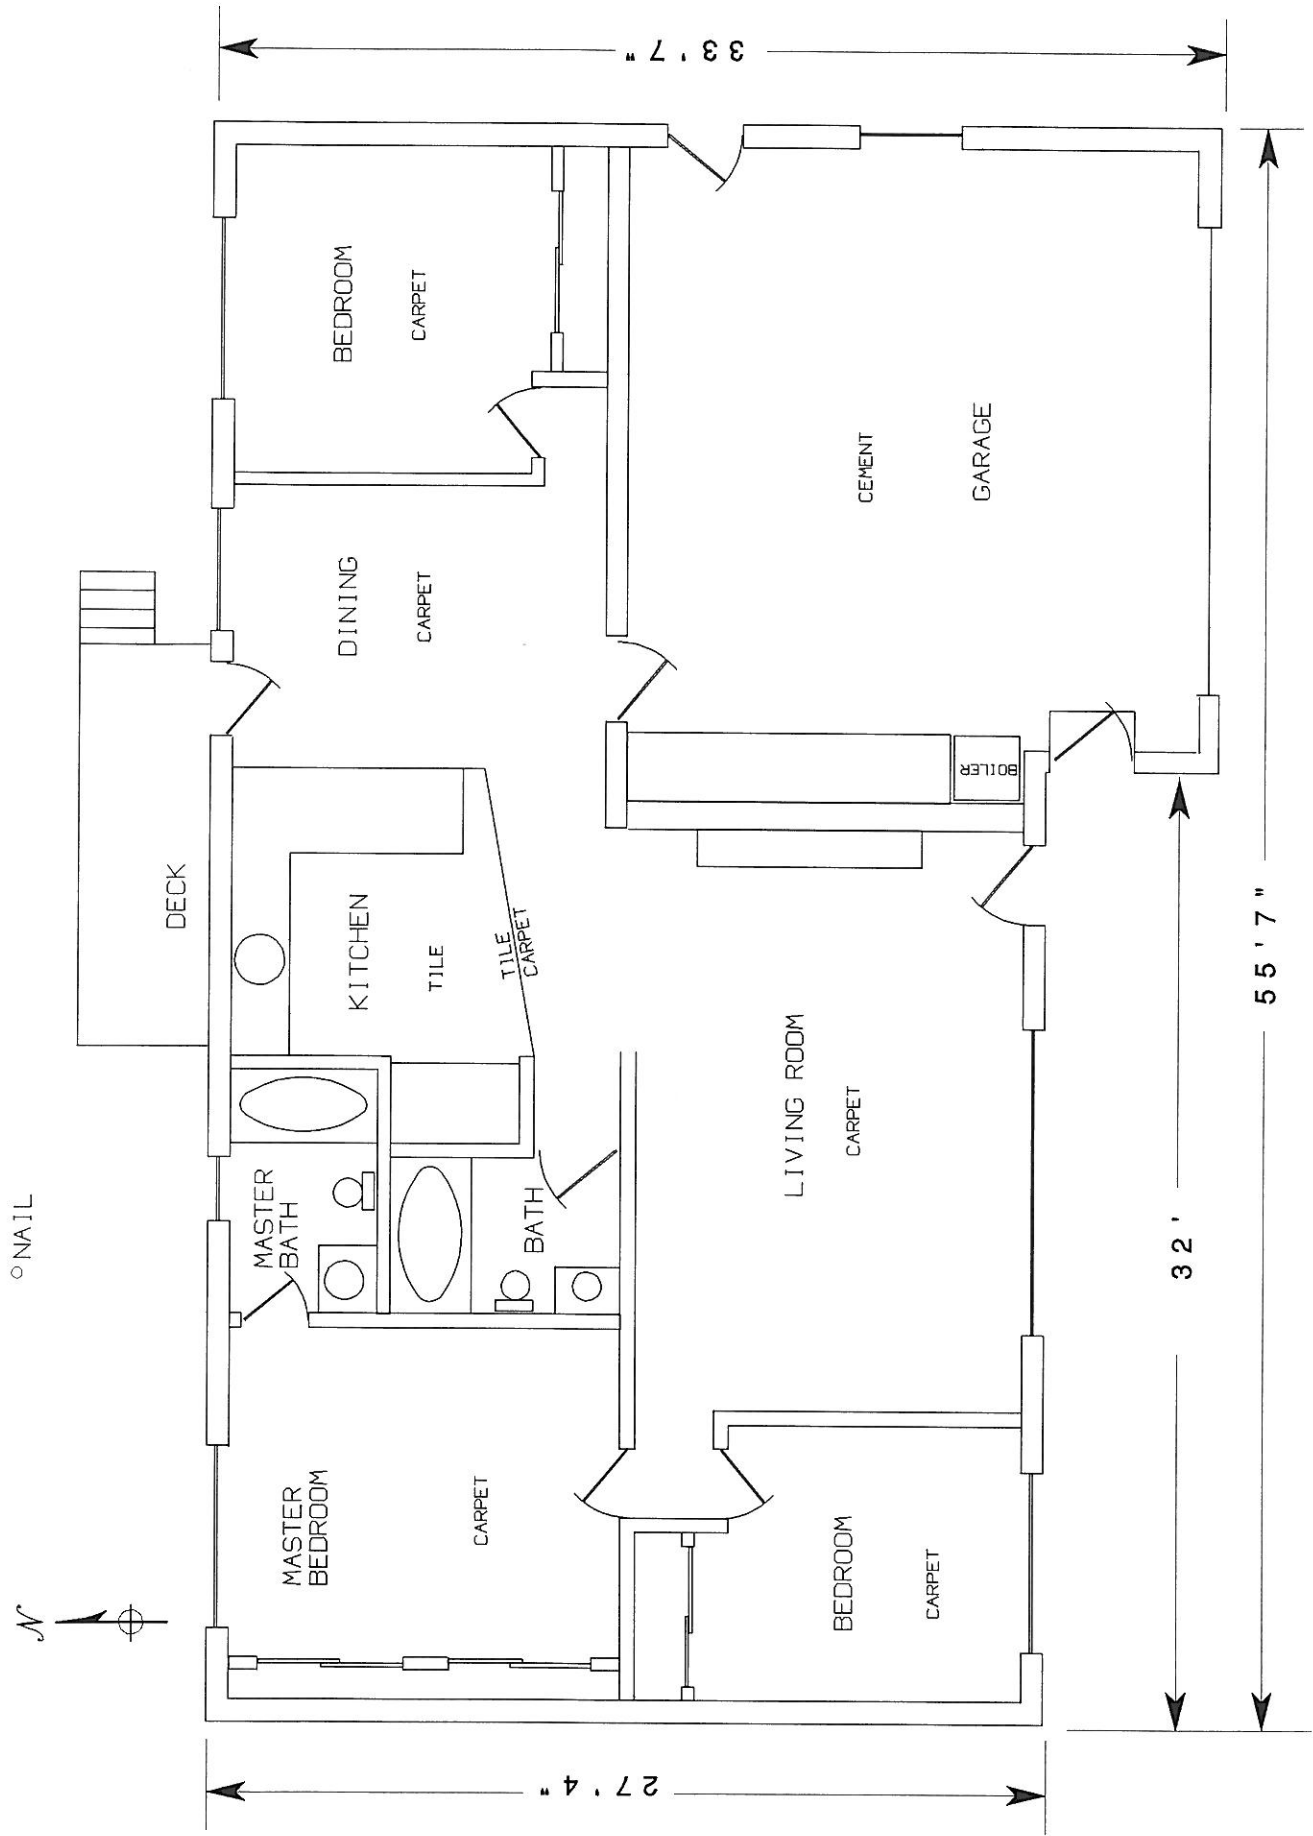
FIGURE 1 Floor Plan of 4720 STANFORD Drive

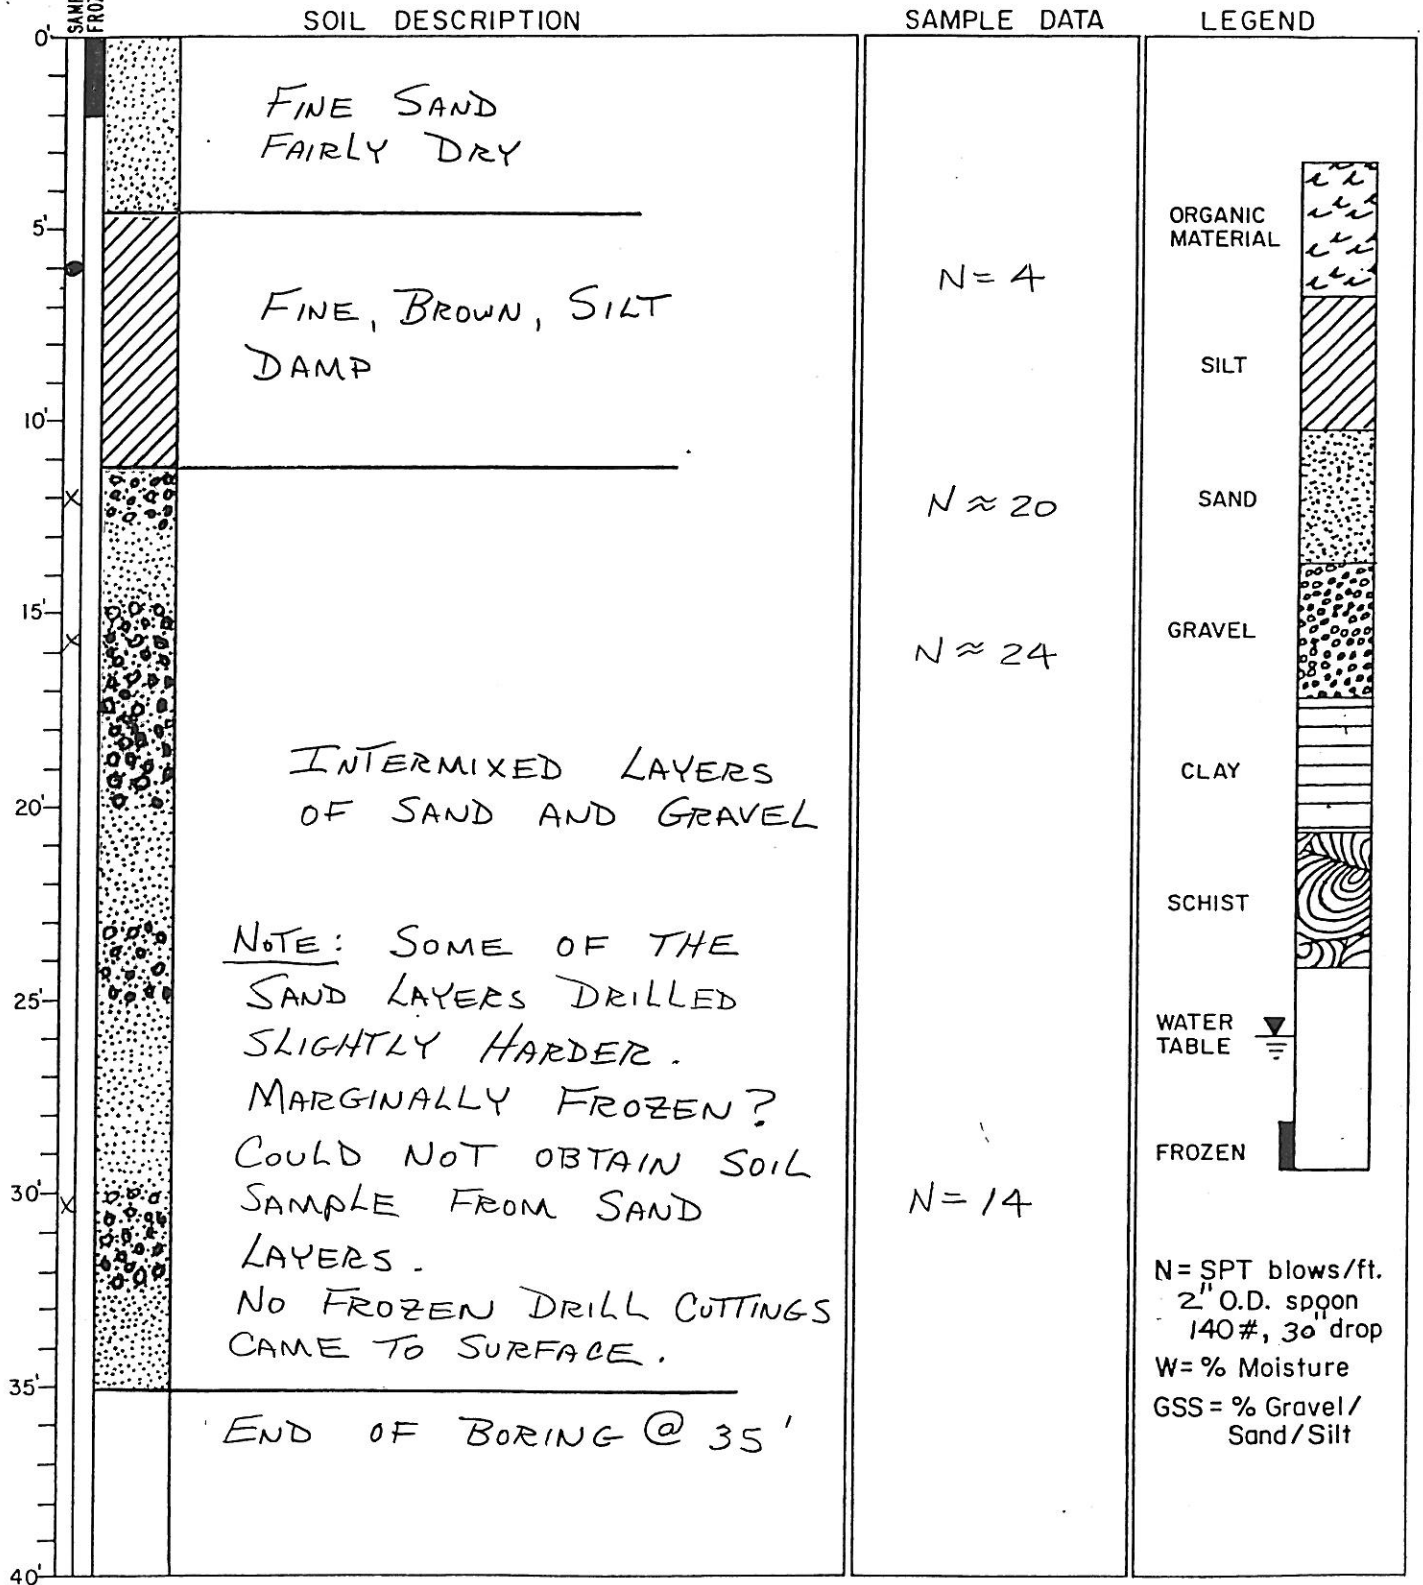
N = SPT blows/ft.
2" O.D. spoon
140#, 30" drop
W = % Moisture
GSS = % Gravel/
Sand/Silt

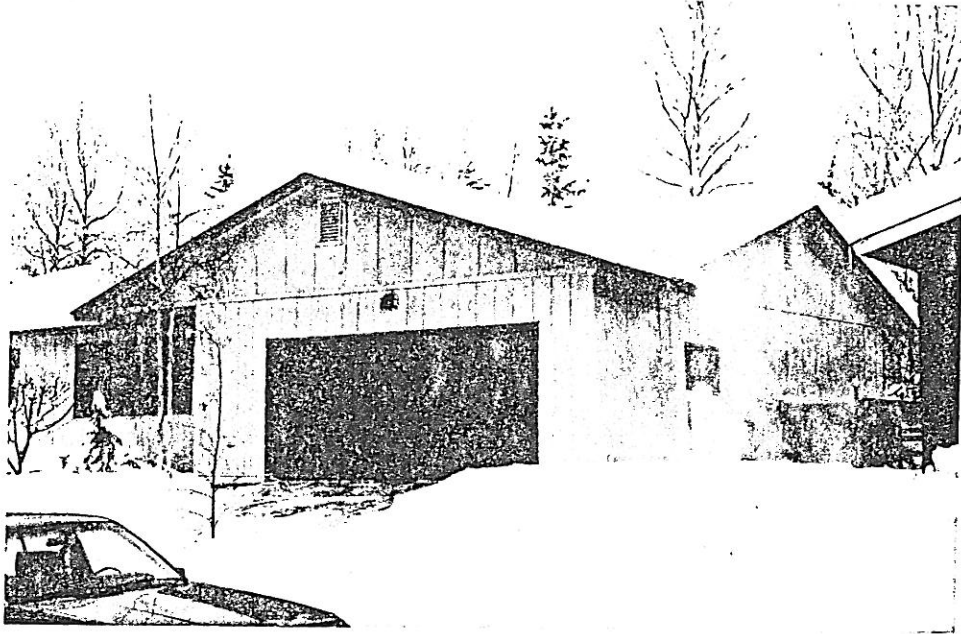
PHOTO #1: FRONT OF GARAGE AND SOUTHEAST END OF HOUSE.
NOTE ELEVATION ABOVE STREET.

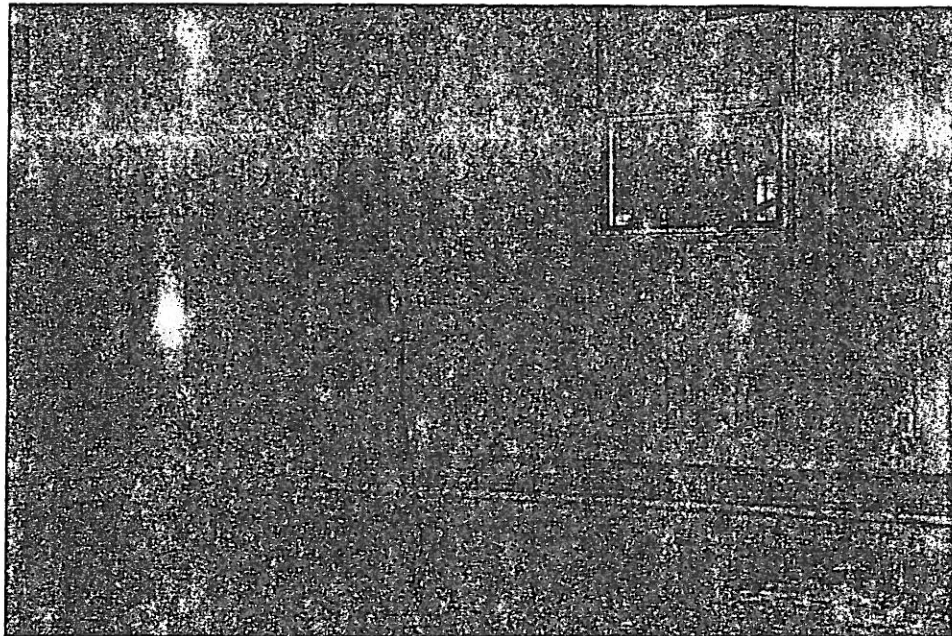
PHOTO #2: LOOKING AT SOUTHEAST END OF GARAGE. NOTE CRACK
AND SETTLEMENT OF GARAGE SLAB IN CENTER FOREGROUND, JUST
BELOW WINDOW.

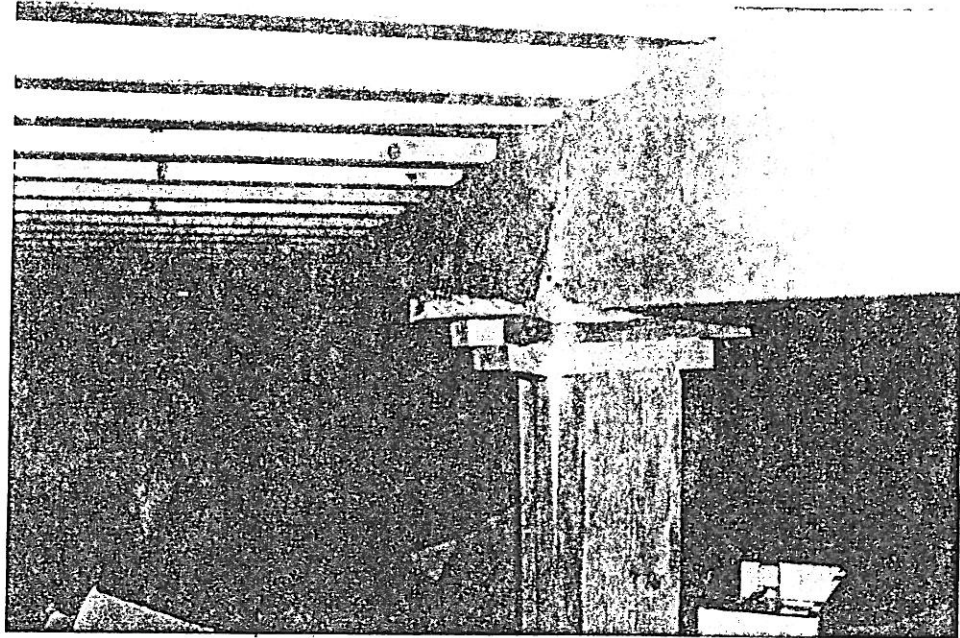
PHOTO #3: MAIN BEAM SUPPORTING FLOOR JOISTS. NOTE TWISTING DUE TO SHIMMING AND LACK OF LATERAL RESTRAINT.

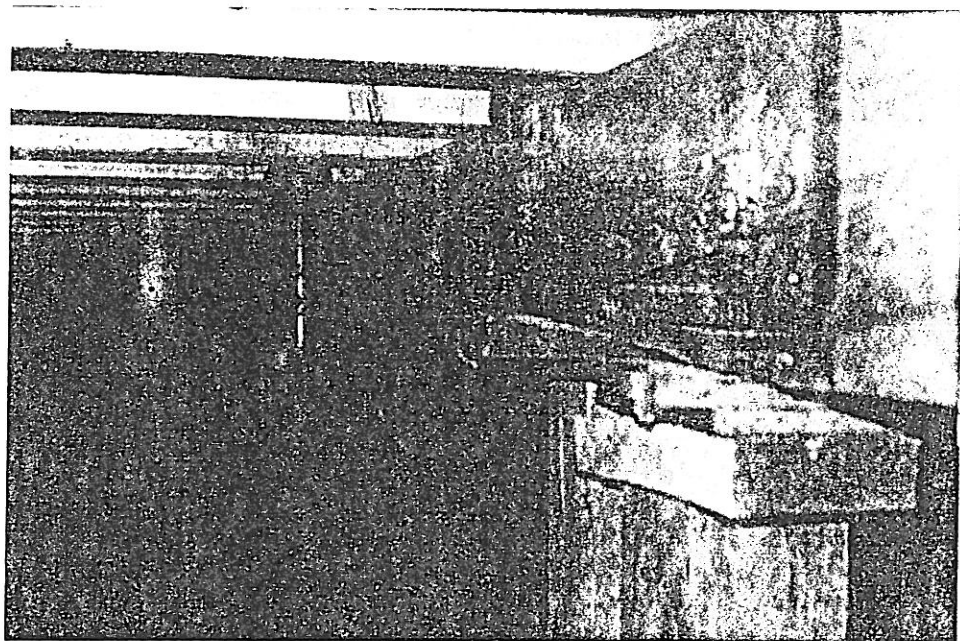
PHOTO #4: CRUSHING AND FAILURE OF MAIN BEAM DUE TO INSUFFICIENT BEARINGS ON SHIMS.

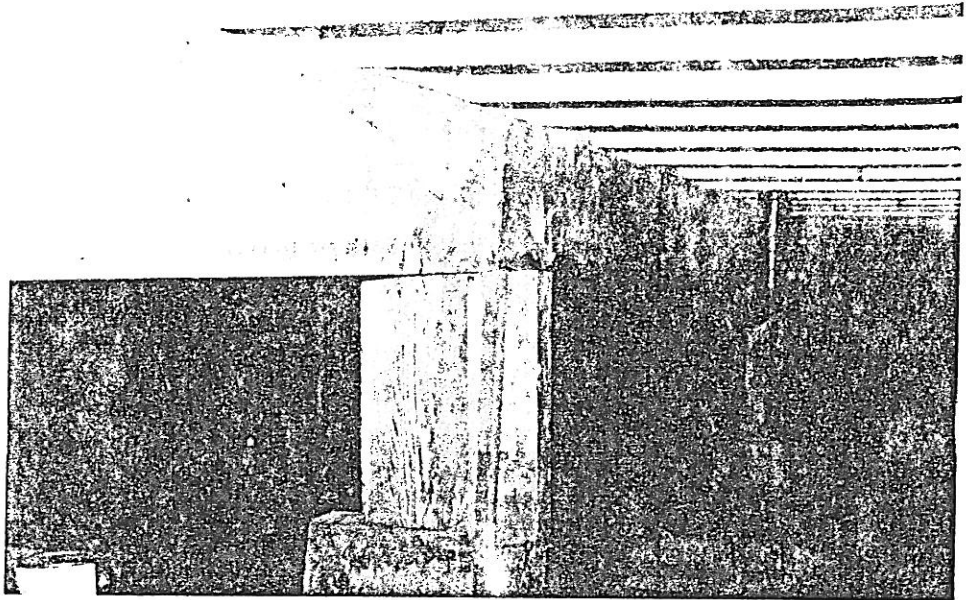
PHOTO #5: VERTICAL MISALIGNMENT OF MAIN BEAM AT BUTT JOINT
DUE TO POOR SUPPORT SYSTEM.

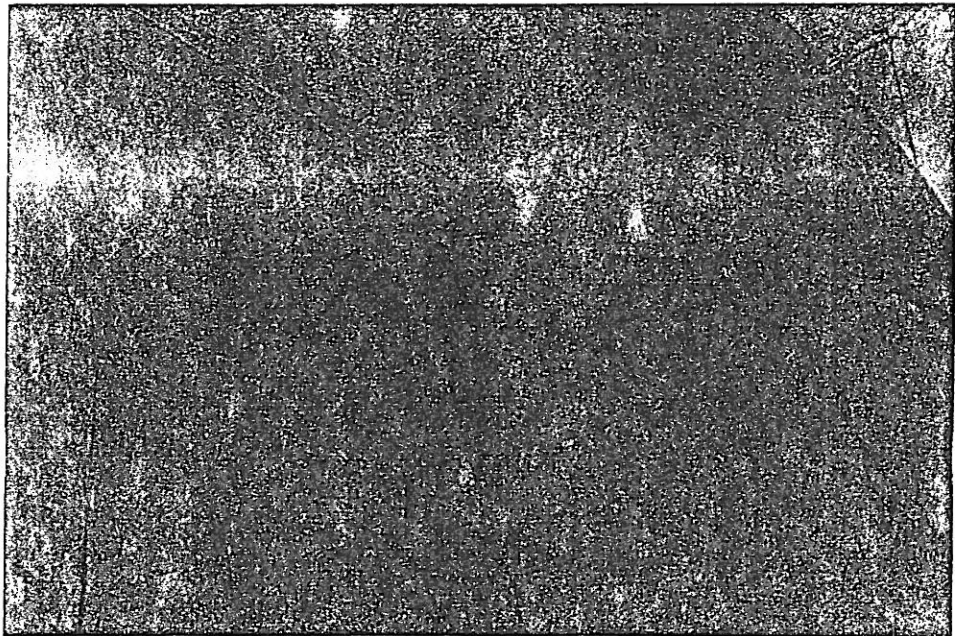
PHOTO #6: MINOR CRACKING OF SHEETROCK IN GARAGE AT
WALL-CEILING JOINT, DUE TO WEAK GARAGE CEILING BEAM
AND/OR BUILDING SETTLEMENT.

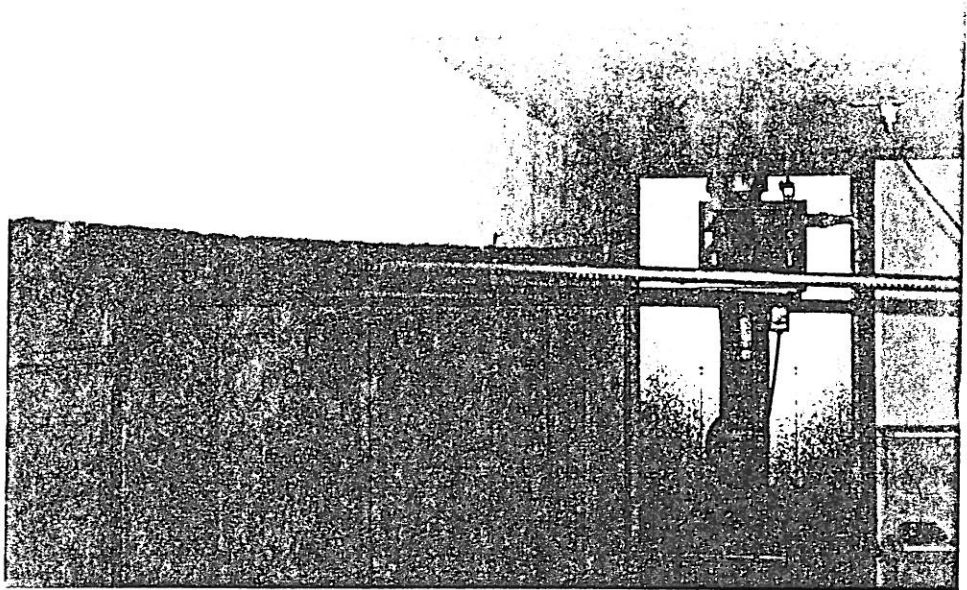
PHOTO #7: SHEETROCK ENCASED WOOD BEAM SUPPORTING FRONT END OF MAIN ROOF TRUSSES IN GARAGE SHOWS EXCESSIVE SAG.

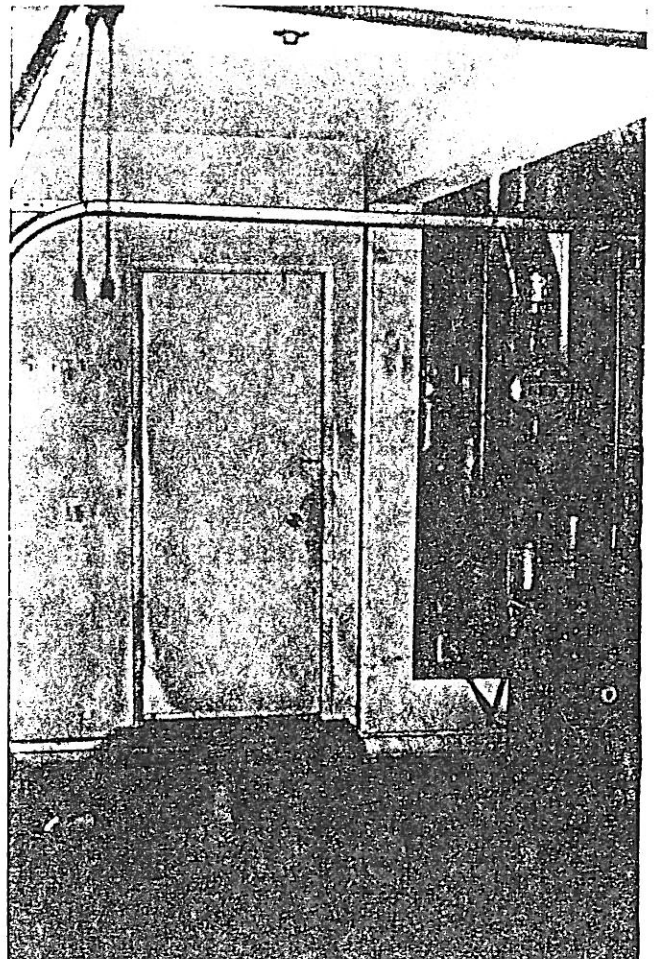
PHOTO #8: NORTHWEST END OF GARAGE CEILING BEAM. NEW COLUMN SHOULD BE LOCATED JUST BEYOND OVER-HEAD DOOR TRACK AND NEXT TO BOILER.

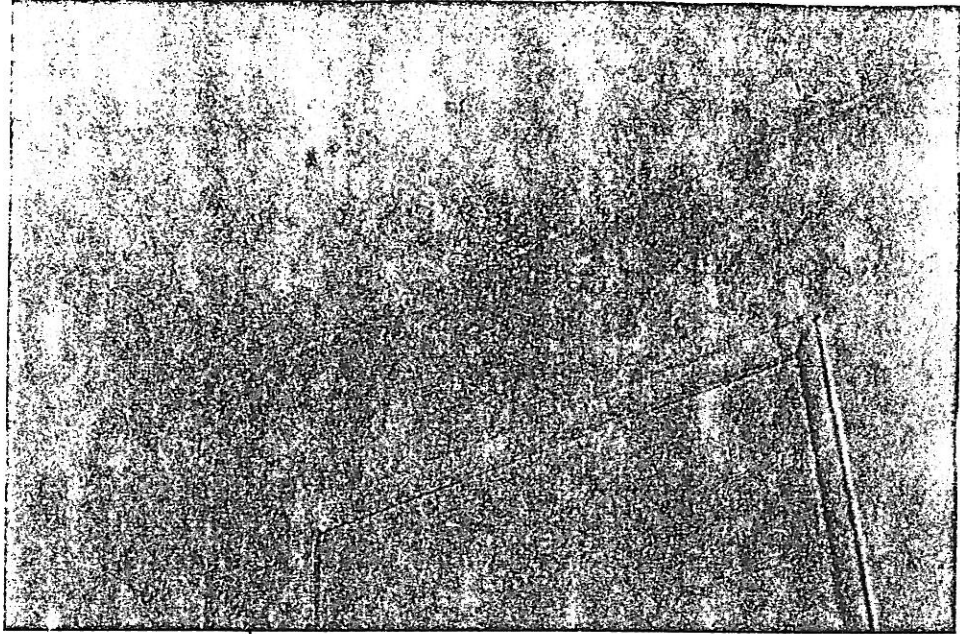
PHOTO #9: WATER STAINING OF LIVING ROOM CEILING OVER MAIN ENTRY DOOR. THIS IS LOCATED AT LOW END OF VALLEY IN HIP ROOF.

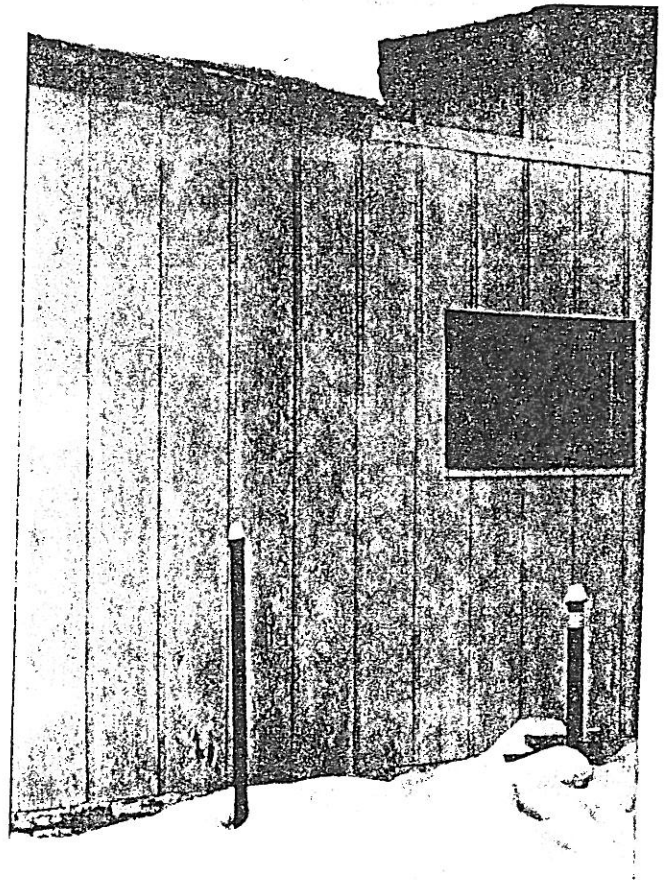
PHOTO #10: WATER DAMAGE TO EXTERIOR FINISH ON SOUTHEAST END OF GARAGE, JUST BELOW VALLEY IN HIP ROOF.
