FINAL REPORT

FOUNDATION STABILIZATION RESEARCH
STUDIES at

263 Madcap Lane

March 1999

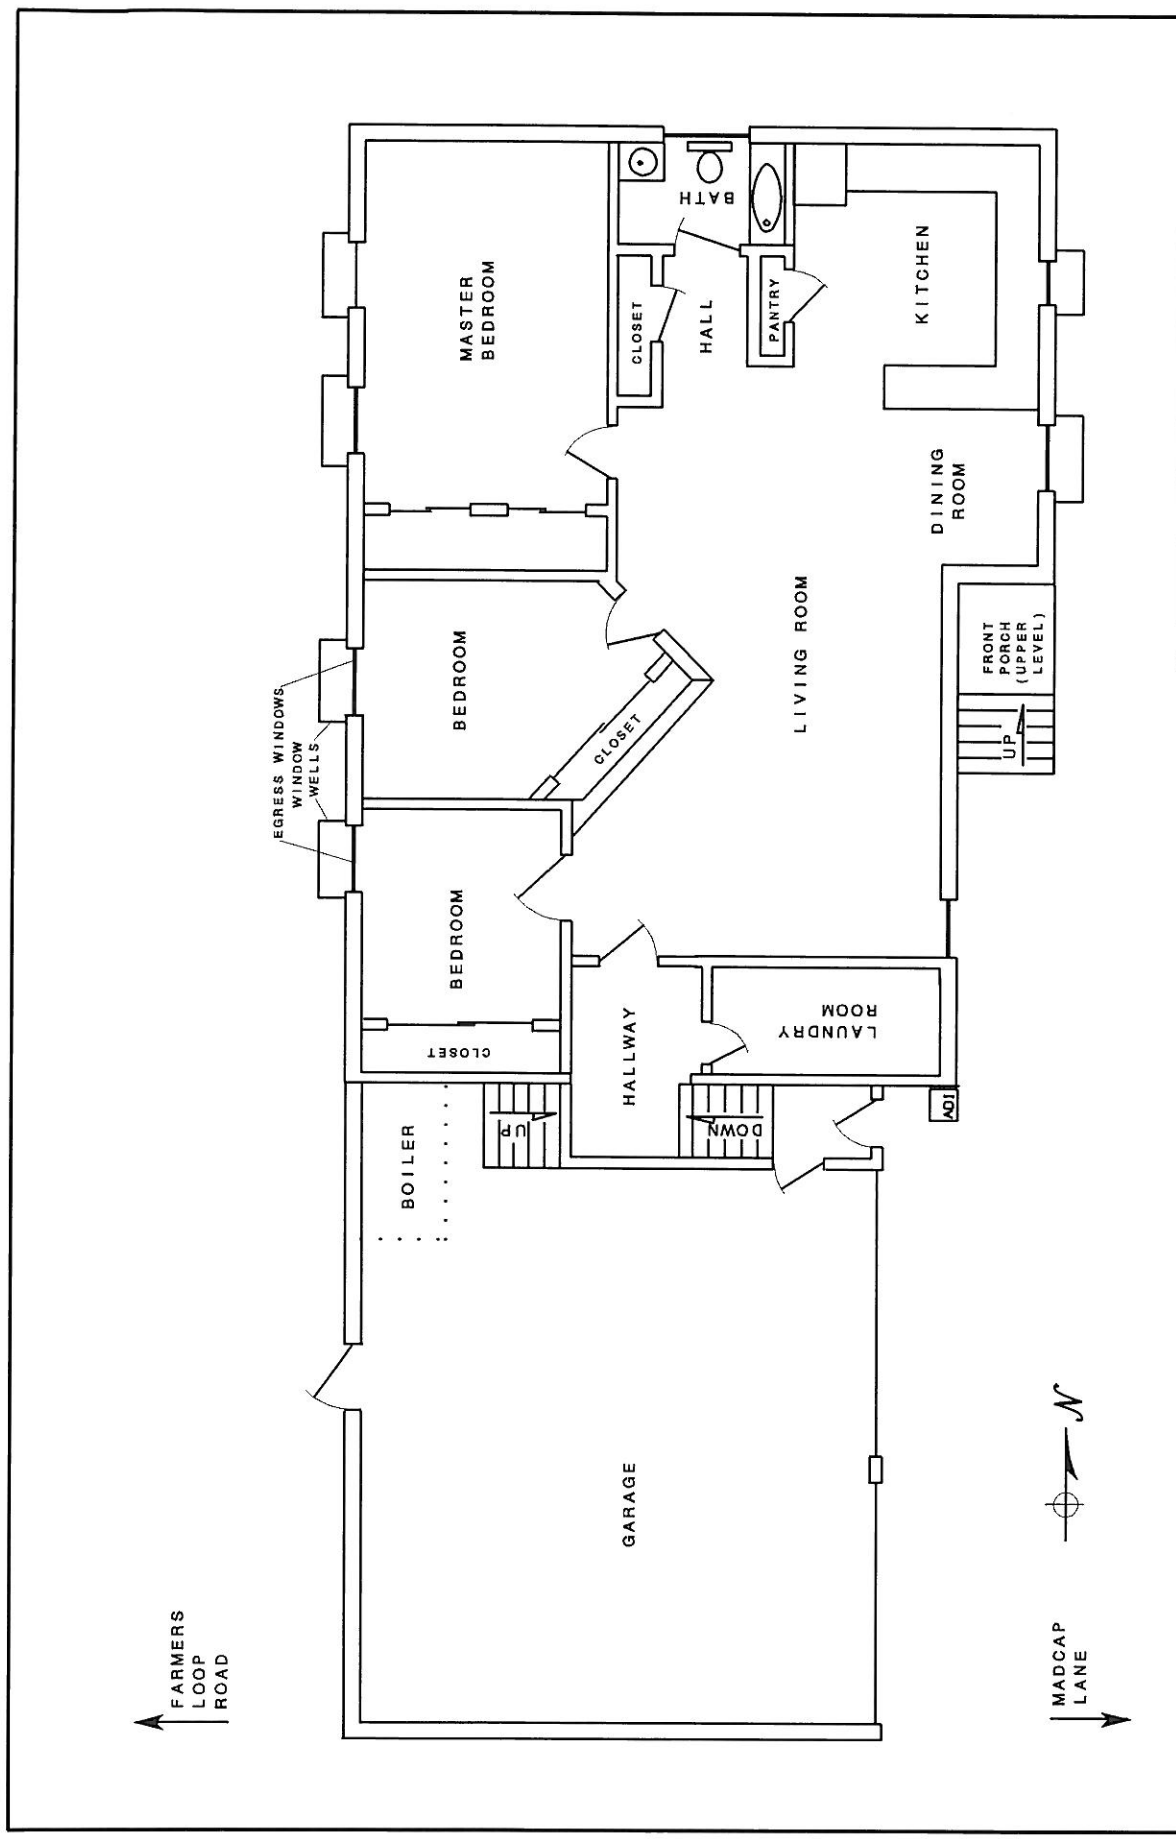
FIG. 1

**PERMAFROST TECHNOLOGY
 FOUNDATION**
 263 MADCAP LN. FAIRBANKS, AK
 BASEMENT AND GARAGE
 FLOOR PLAN

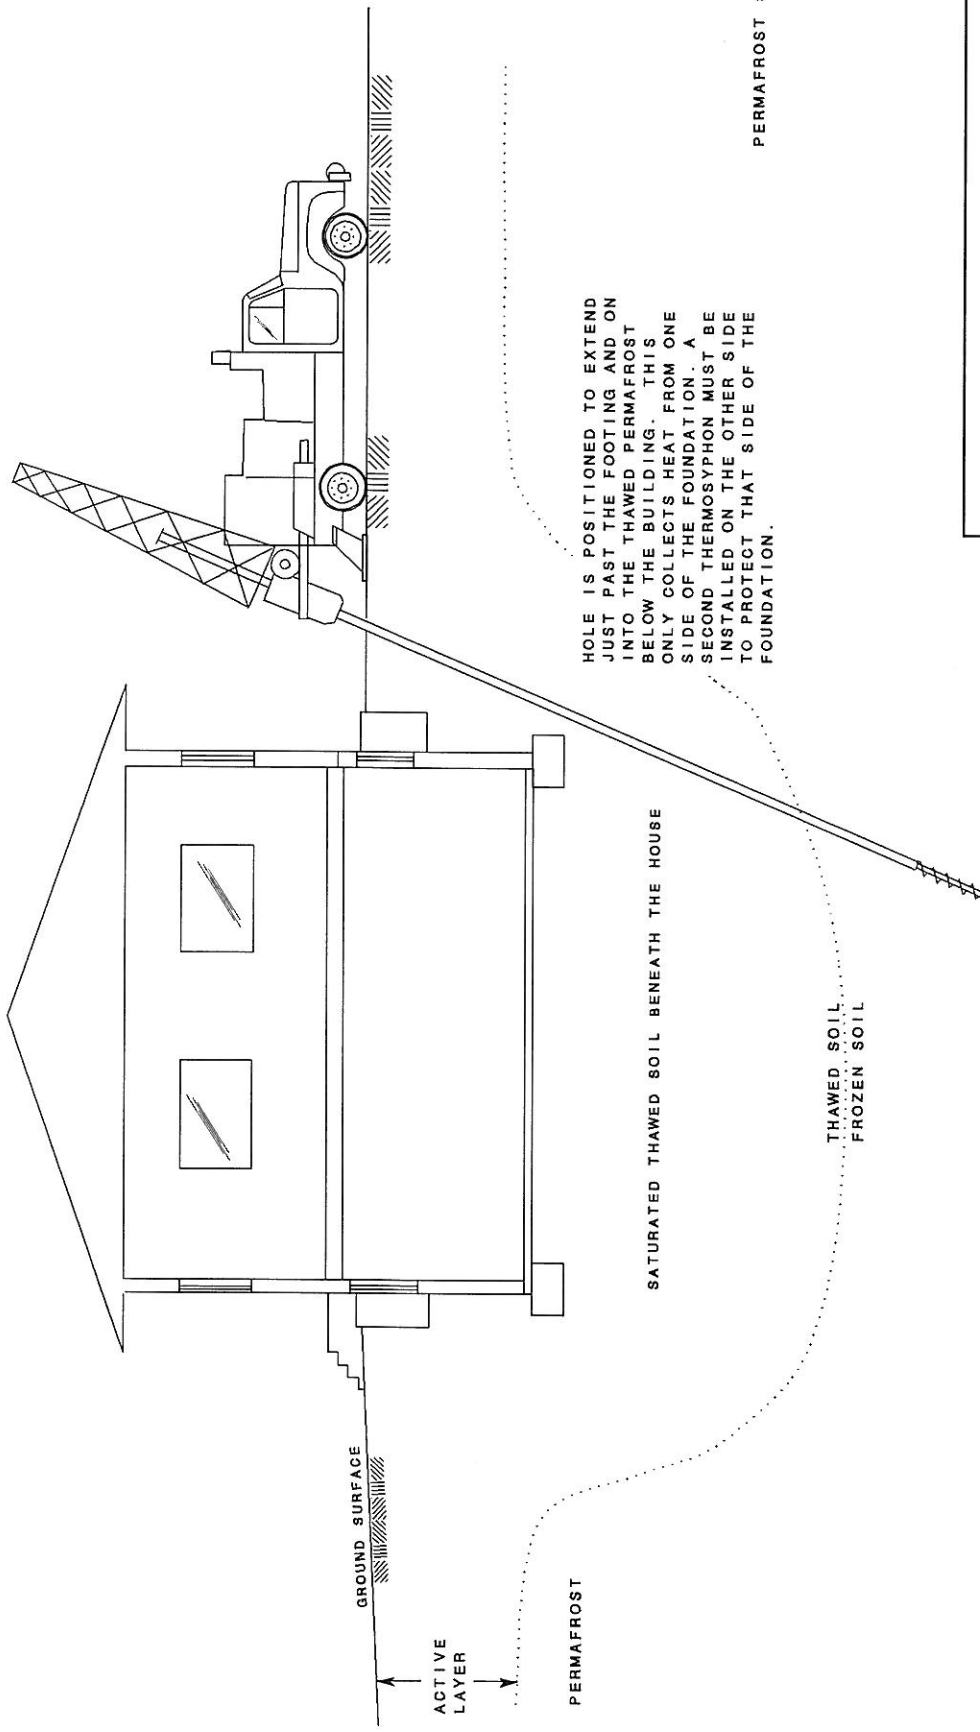
TYPICAL ANGLE INSTALLATION OF THERMOSYPHONS AROUND A BUILDING

HOLE IS POSITIONED TO EXTEND JUST PAST THE FOOTING AND ON INTO THE THAWED PERMAFROST BELOW THE BUILDING. THIS SIDE OF THE FOUNDATION. A SECOND THERMOSYPHON MUST BE INSTALLED ON THE OTHER SIDE TO PROTECT THAT SIDE OF THE FOUNDATION.

hole into the ground at an angle such that the hole extends beneath the footing of the structure (figure 4). The heat pipe is then placed in the hole and the annulus around the pipe is filled with a slurry of soil to provide good heat transfer characteristics between the soil and the heat pipe.

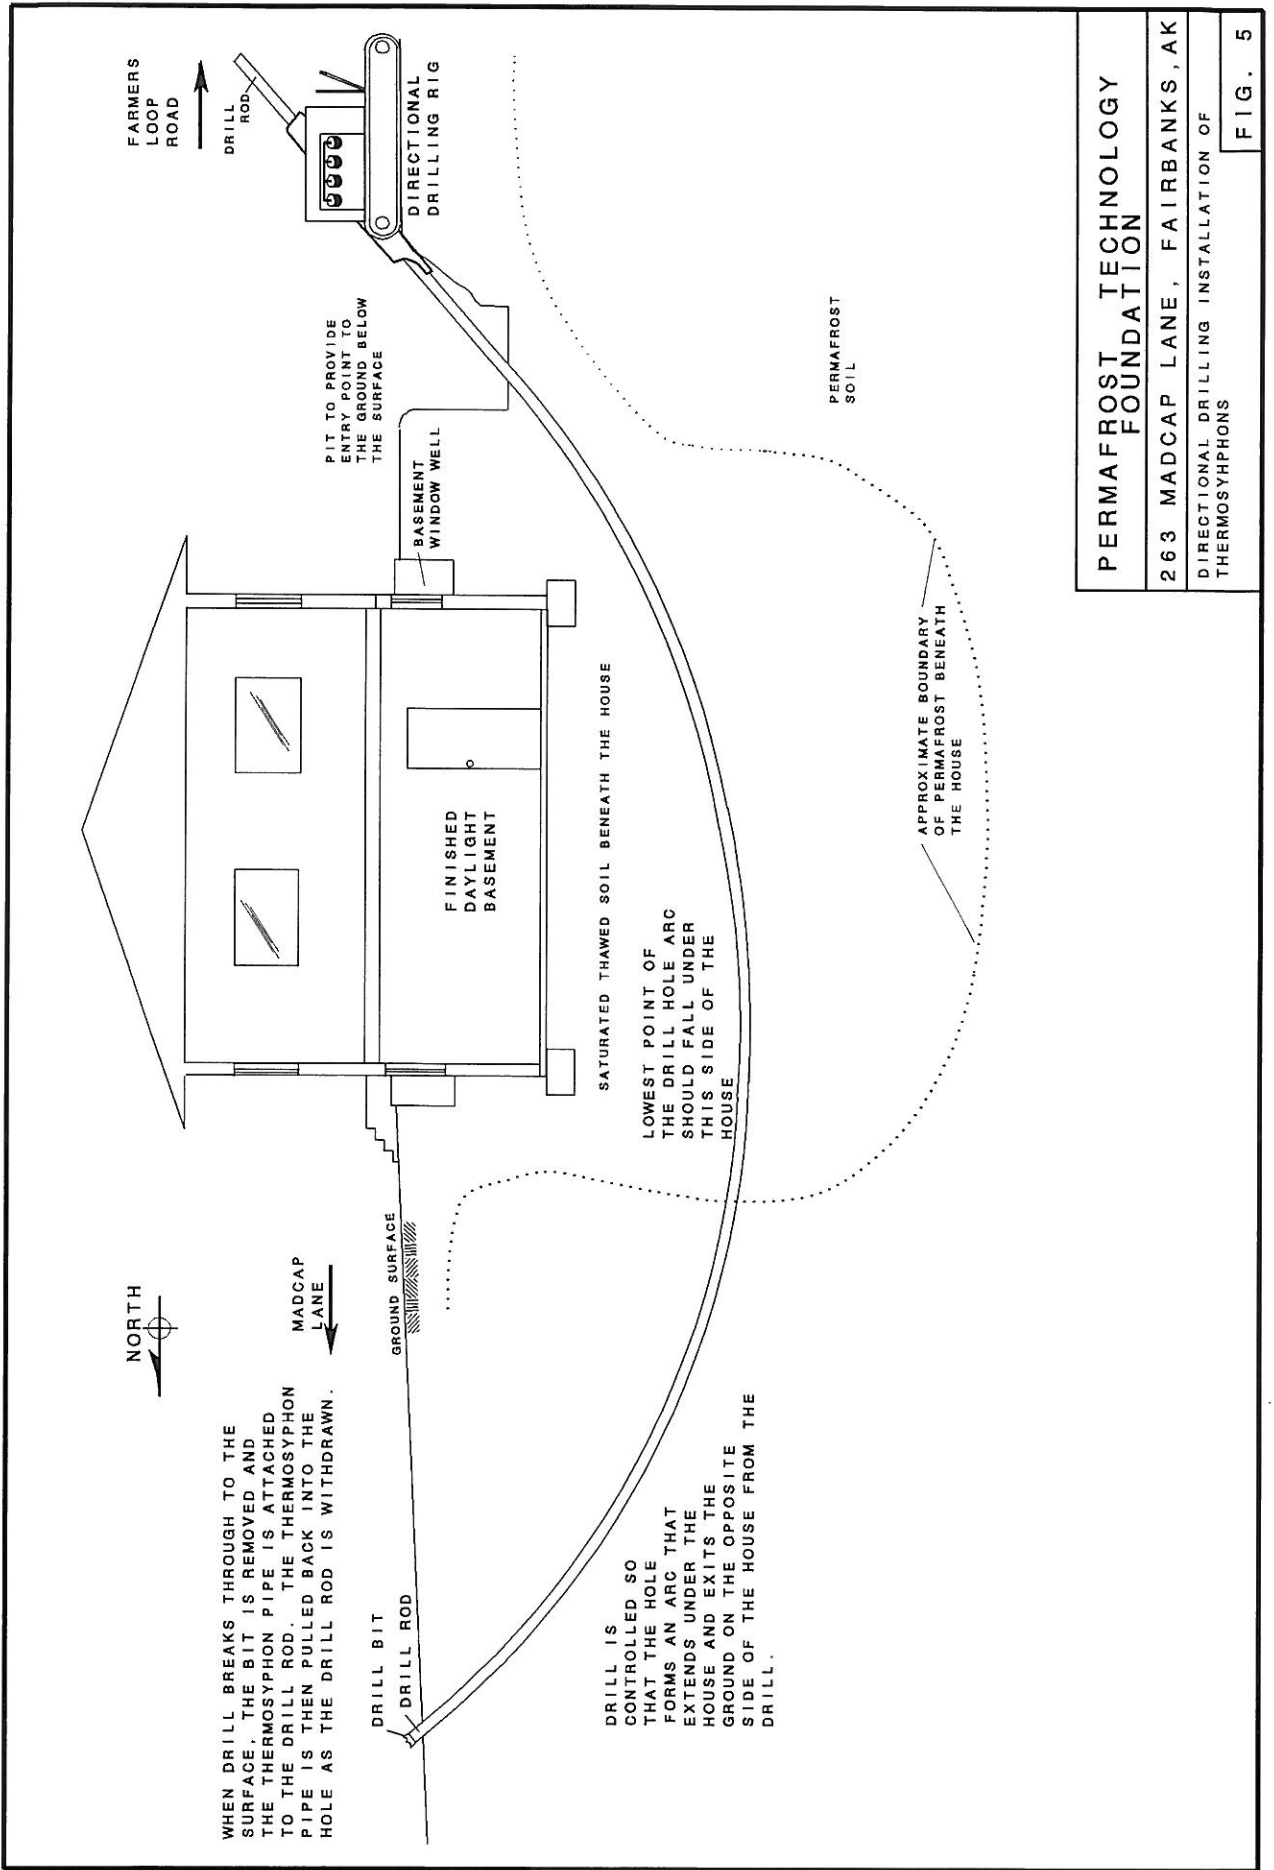
FIG. 5

DIRECTIONAL DRILLING INSTALLATION OF THERMOSYPHONS

In order to get the pipe into its location without the problems associated with using it as a drill stem, a directional drill was used. This drill was capable of drilling the hole in an arc that extended under the building and exited at the surface on the opposite side of the building (figure 5.) The drill bit was then removed and the previously prepared thermosyphon pipe was attached to the drill stem (which was still in the hole and extended under the house). As the drill stem was withdrawn from the hole the attached thermosyphon pipe was pulled into the hole. In this manner, the hole was never left empty, and thus had no opportunity to collapse. The length of the hole arc and the thermosyphon pipe were adjusted so that when the pipe was drawn all the way back to the beginning of the hole, the buried end of the thermosyphon was at the deepest point of the arc. The hole was directionally controlled so that the deepest portion of the arc was under the foundation wall on the opposite side of the building (figure 6). The evaporator section of the thermosyphon was thus positioned so that it extended under the entire width of the building, and its end was at the lowest point of the arc. This provided a

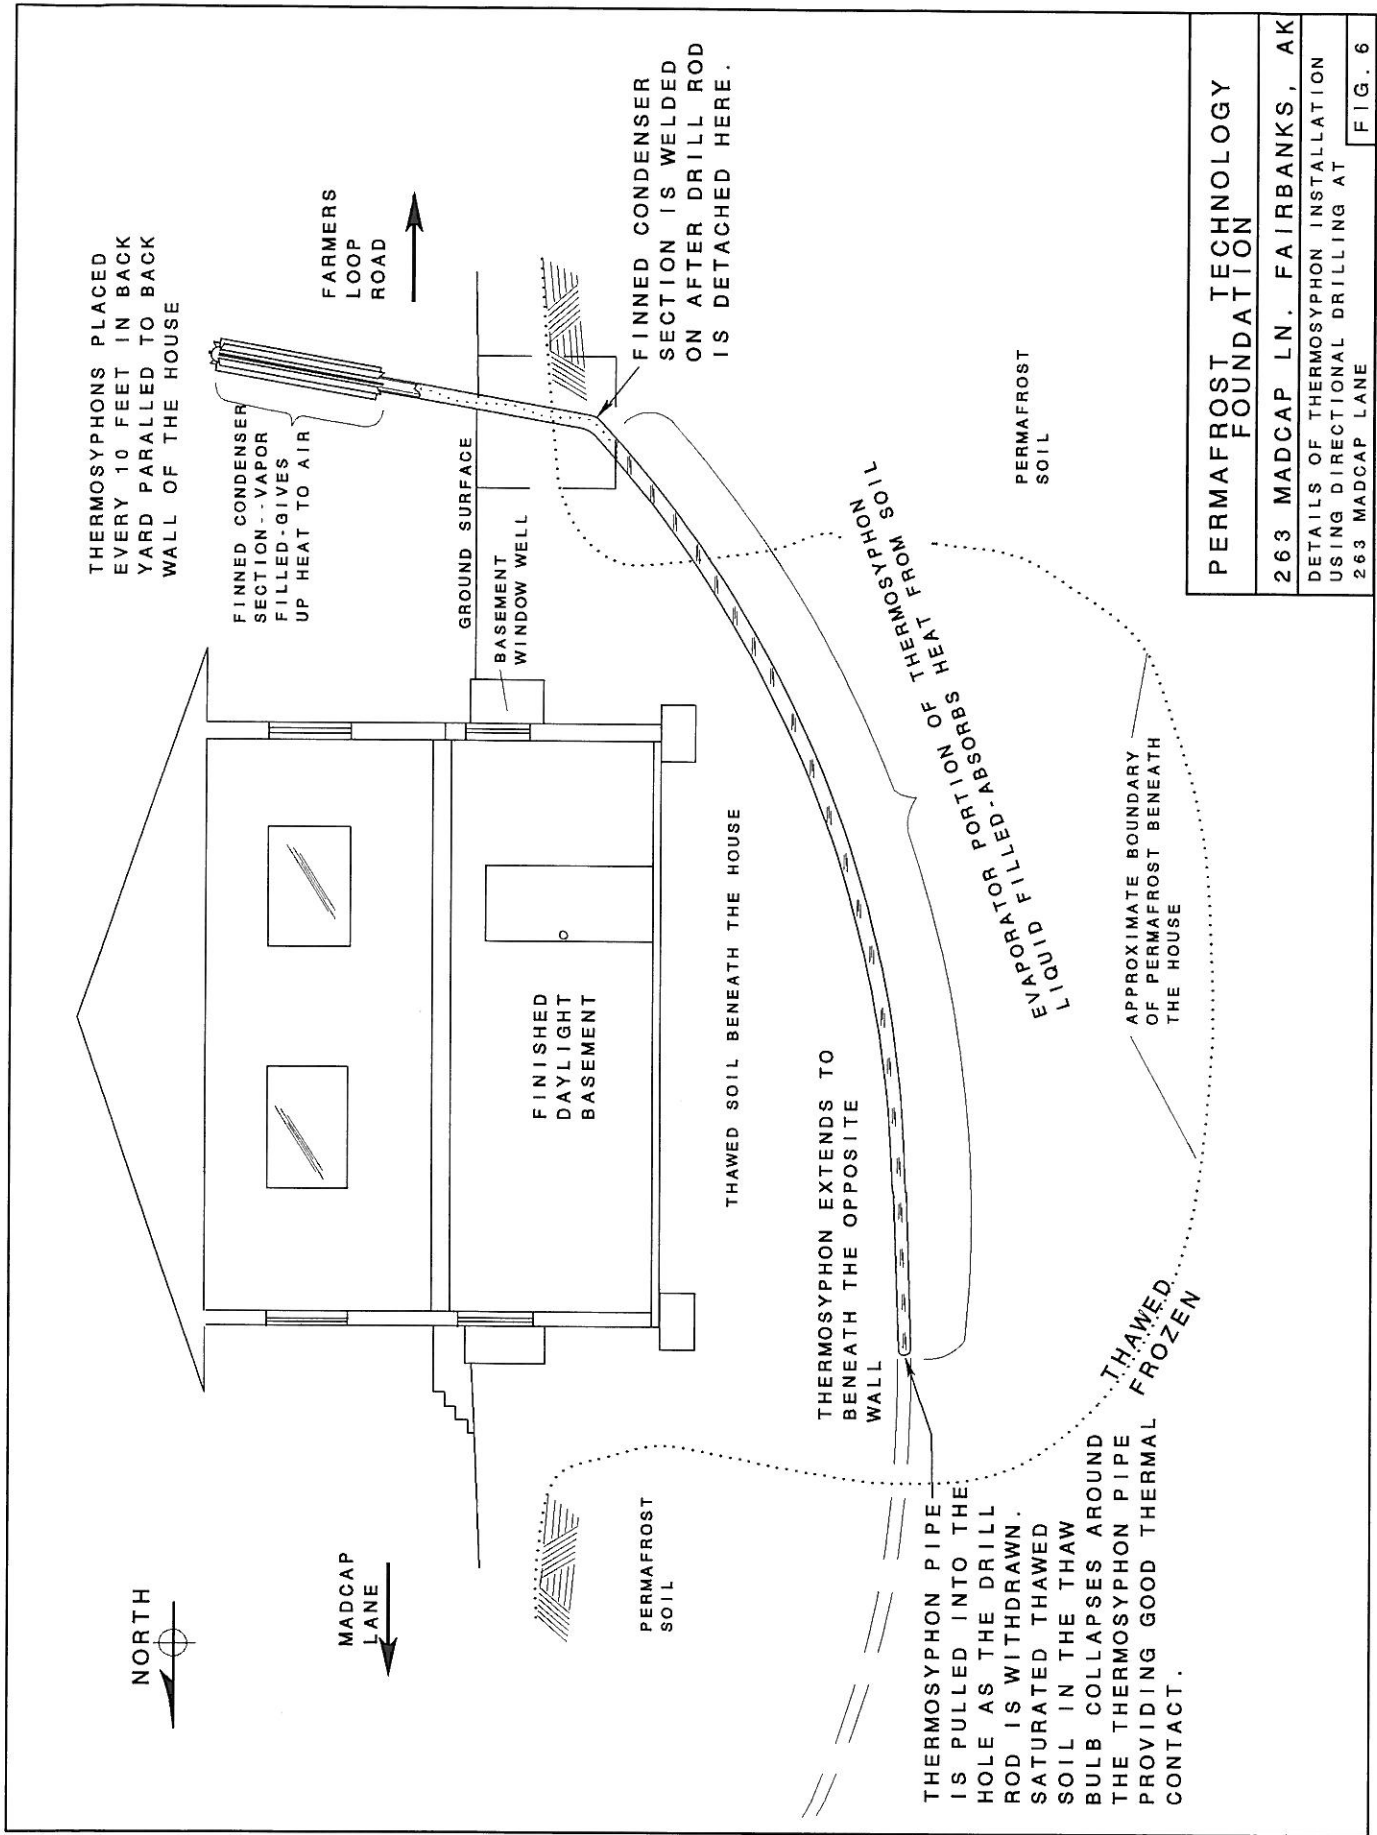
THERMOSYPHONS PLACED EVERY 10 FEET IN BACK YARD PARALLEL TO BACK WALL OF THE HOUSE

PERMAFROST TECHNOLOGY FOUNDATION
 263 MADCAP LN. FAIRBANKS, AK
 DETAILS OF THERMOSYPHON INSTALLATION USING DIRECTIONAL DRILLING AT 263 MADCAP LANE
 FIG. 6

Six thermosyphons were installed using the above technique. Calculations showed that a spacing of 10 feet apart across the back of the house at Madcap Lane would produce a shield of frozen soil that would intercept heat from the floor and walls of the heated basement to protect the permafrost from further thawing. Installation attempted to match the ten foot spacing although the first two were not spaced correctly due to miscommunication with the drill operators. (figure 7) shows the thermosyphon locations as well as other instrumentation and measurement details. The condenser portions are all in the back yard where they are less intrusive. From the front of the house there is no indication of the thermosyphons' presence.

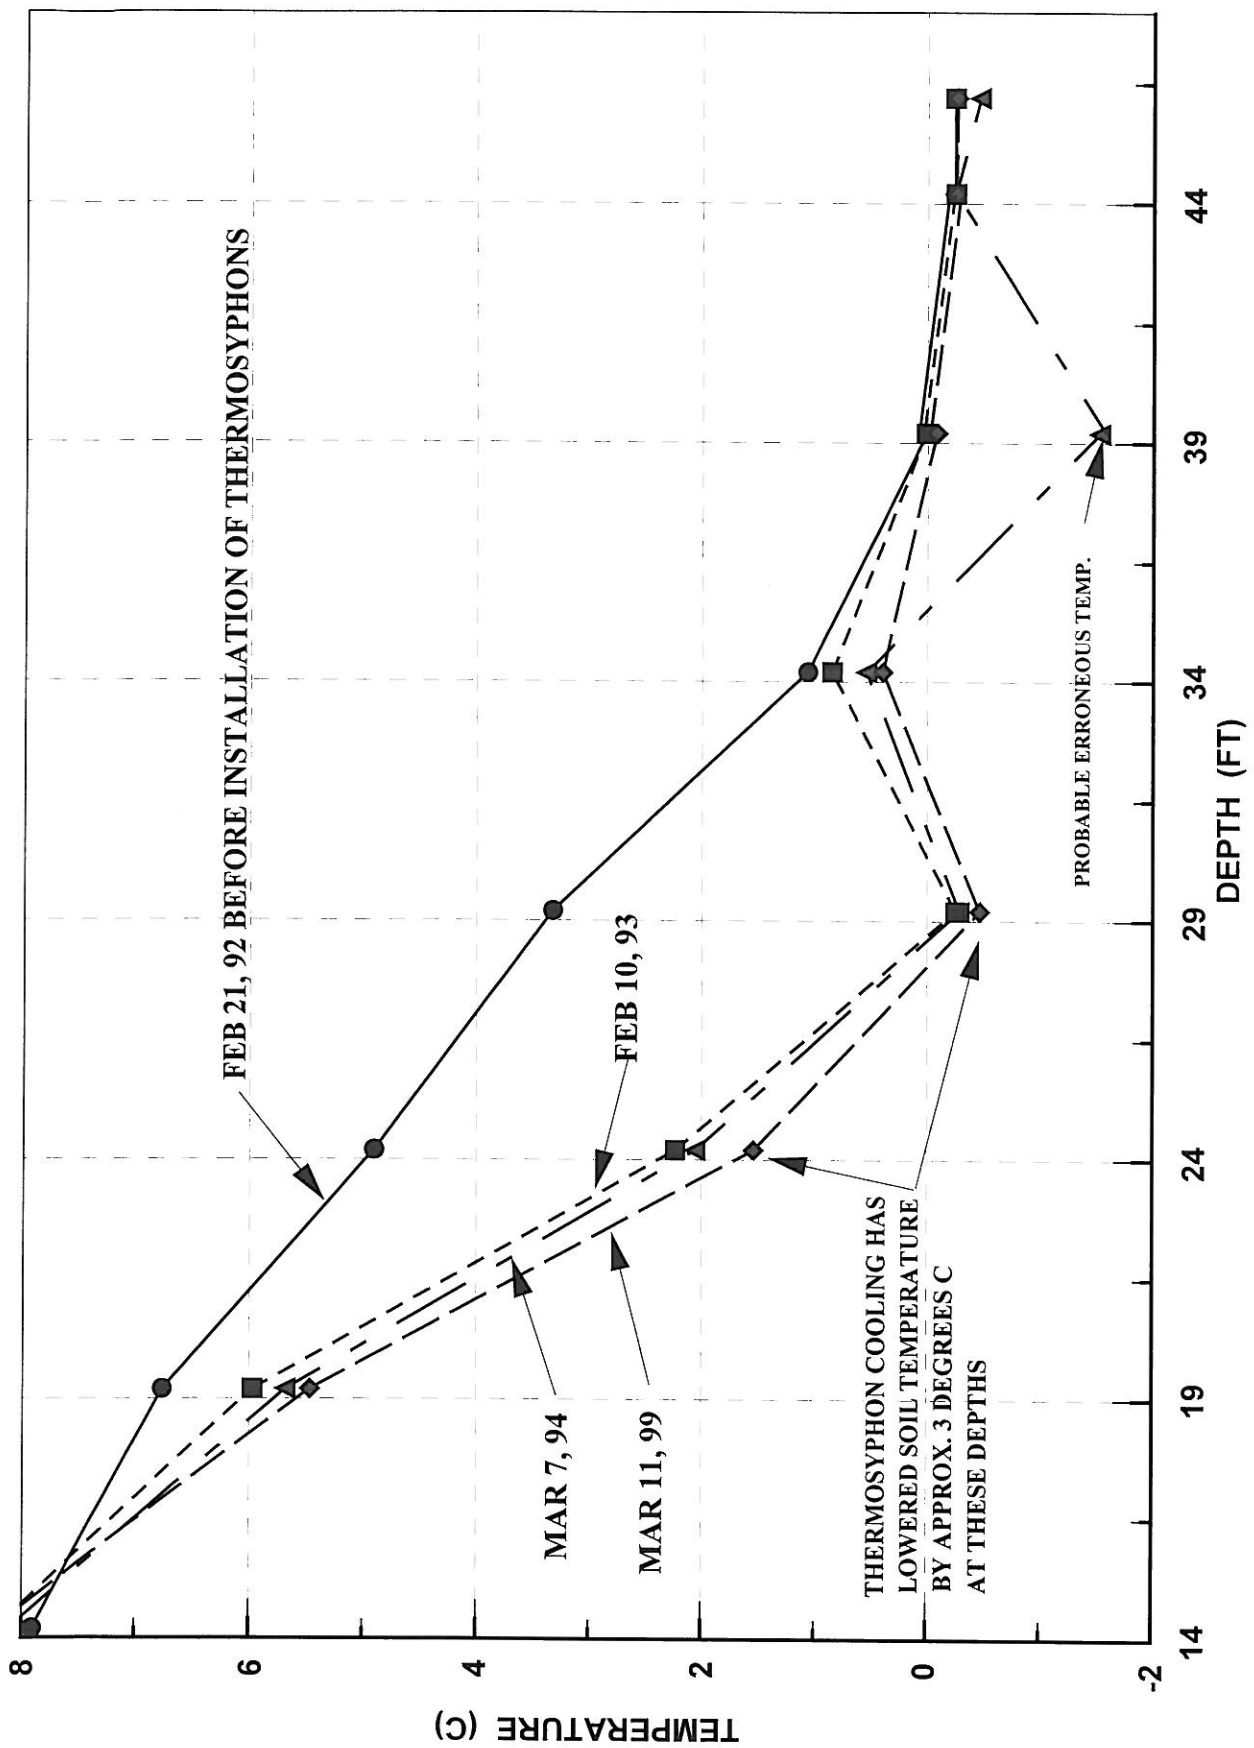
FIGURE 16 - TEMPERATURE OF THERMISTOR STRING 3 vs DEPTH

The thermal influence of the thermosyphons can be seen in the data from thermistor strings no. 3 and no. 4 which are buried under the floor slab in the basement (fig. 7). figures 16 and 17 show plots of temperature vs. depth at various times during the experiment. The general depth of the thermosyphon can be seen in each plot as the locally depressed temperature at approximately 29 feet at the east wall of the house (thermistor string 3, thermosyphon 5), and at approximately 14 feet deep in the center of the house (thermistor string 4, thermosyphon 5). This data along with the pressure measurements at the end of the experiment confirm that the thermosyphons are performing as they should and are not only intercepting heat entering the soil beneath the house, they have stopped further melting of the permafrost. However the continued mild subsidence (if that conclusion is correct) suggests that more cooling power is required under the center of the basement.

An additional thermosyphon placed between numbers 4 and 5 could bridge the wide spacing that resulted during installation and increase the cooling power. This requires that a directional drilling team be brought in to install the evaporator section of the new thermosyphon.

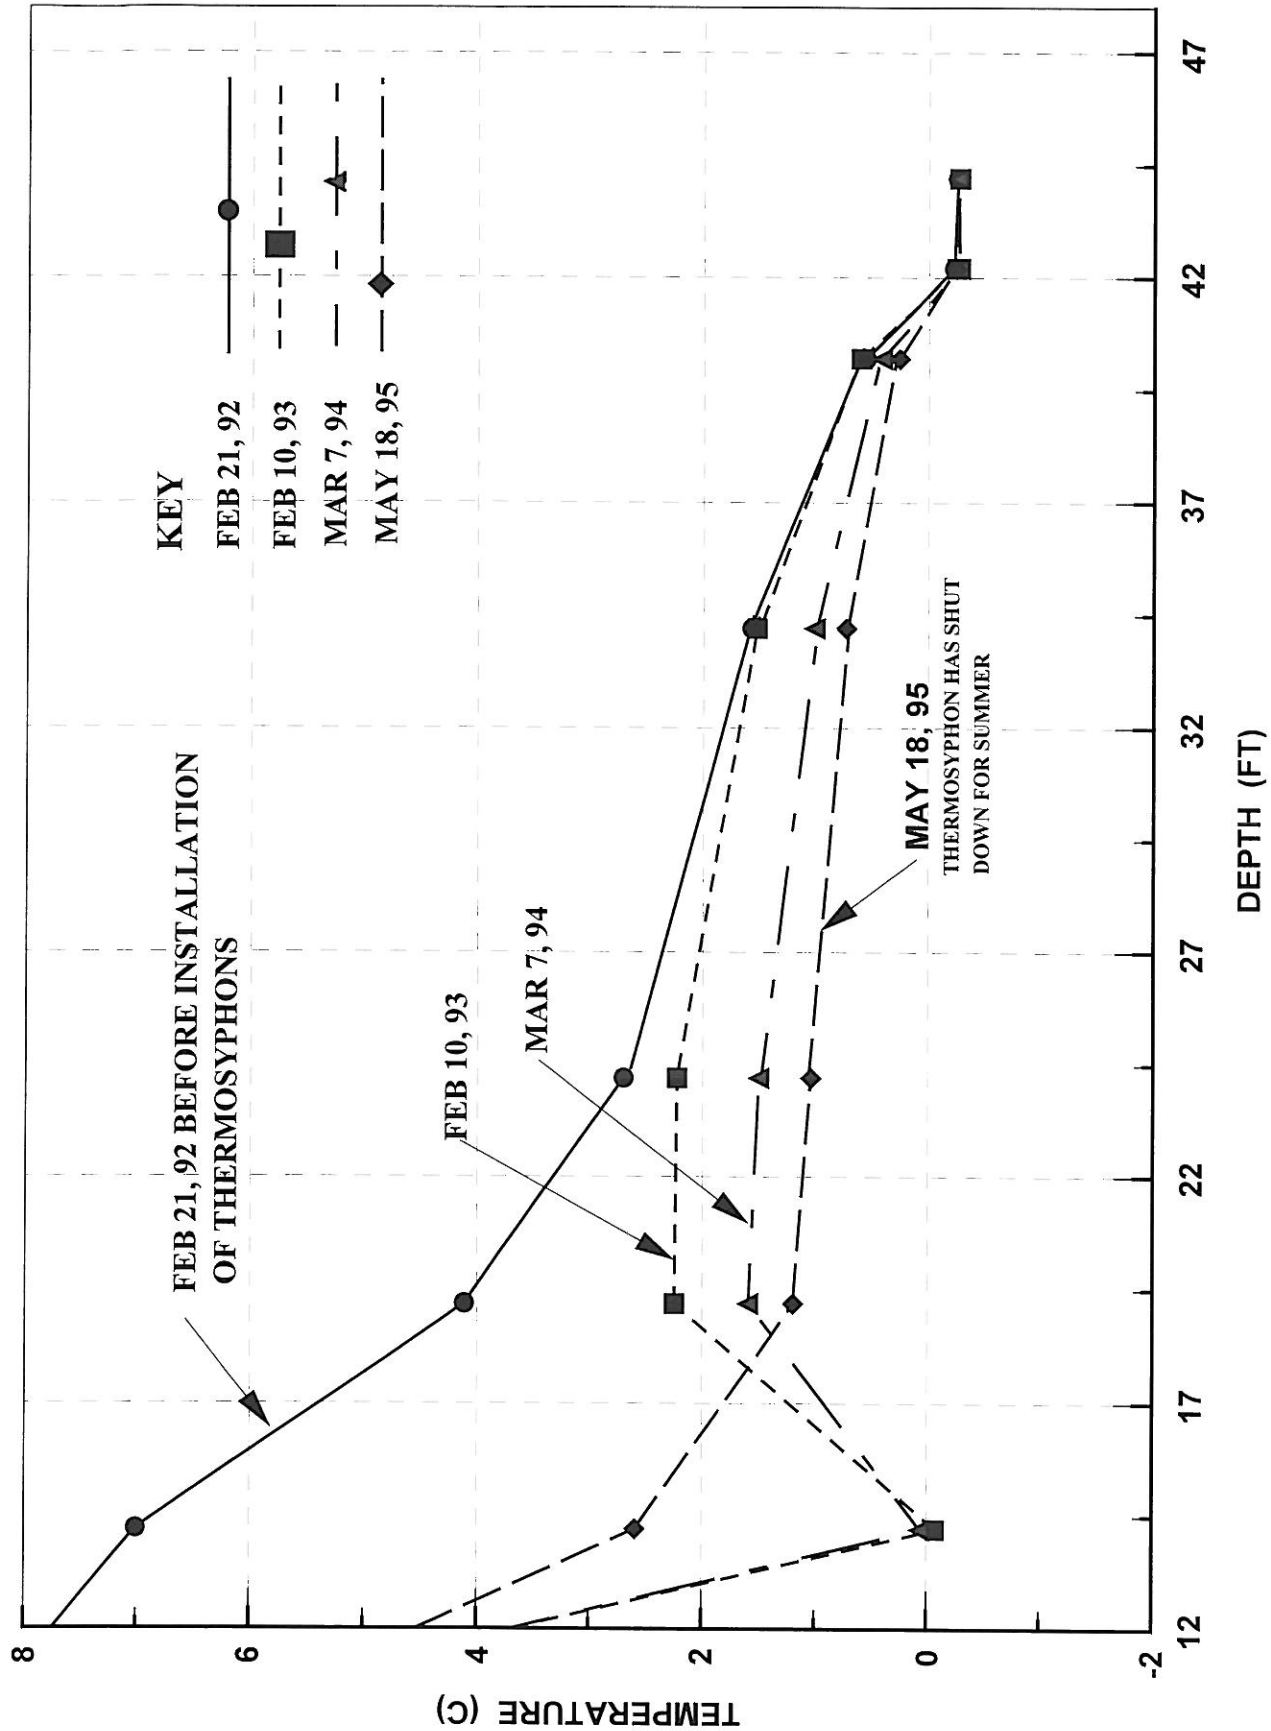
FIGURE 17 - TEMPERATURE OF THERMISTOR STRING 4 vs DEPTH

Temperature data from thermistor string 4 (figure 14) which is under the center of the basement floor slab of the house (see fig. 7) show a steady decline in temperatures beneath the floor (after the thermosyphon installation) until sometime between March 1994 and May 1995 at which time temperatures begin a slight rise. Unfortunately thermistor string 4 ceased operating after May 1995 so no further data is available. Thermistor string 3 (figure 13) which is centered along the east wall of the basement (see fig. 7) shows a very small temperature rise, above the permafrost, but not until after February 1997. Conversely temperatures from thermistor string 2 (figure 15) which is on the southwest end of the building (fig. 7) show a continual decline for the entire period after the thermosyphons were installed in the fall of 1992. This data gives support to the theory of a combination of settlement under the center of the house and heaving at each end.

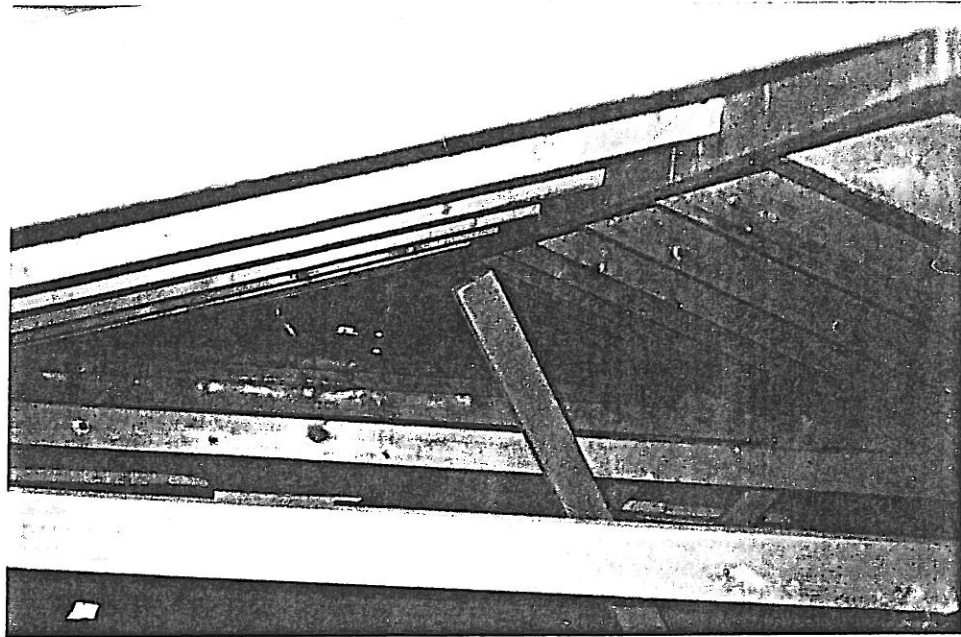
PHOTO #14: THE EXISTING ROOF SYSTEM LOCATED OVER THE HOUSE PORTION OF THE STRUCTURE.

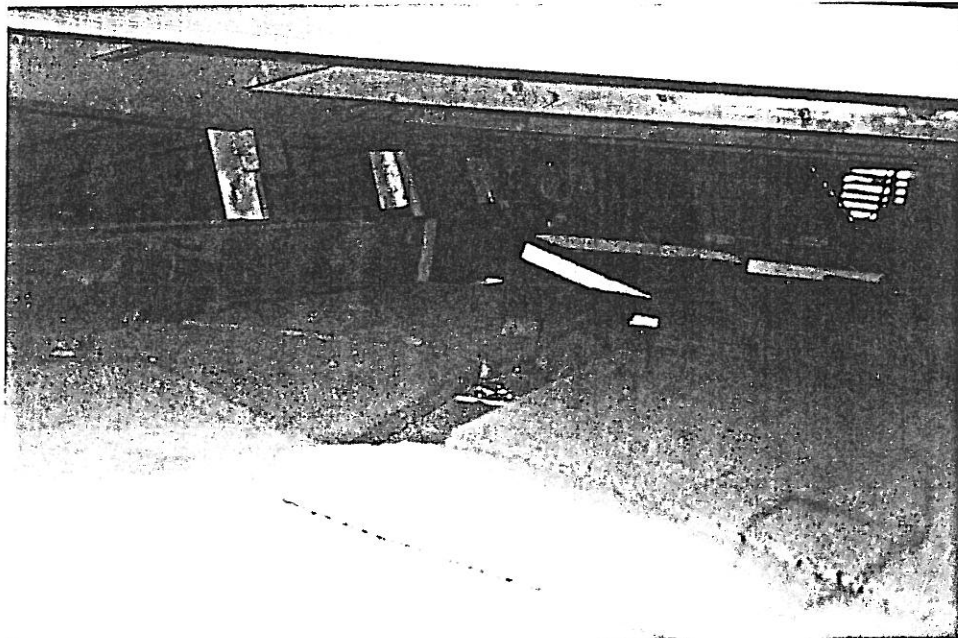
PHOTO #15: THE EXISTING HOUSE ROOF SYSTEM AND INSULATION, RIGID FIBERBOARD AND BEADBOARD INSULATION OVERLAYING THE FIBERGLASS INSULATION.
